LANDSCAPE PEER REVIEW

Bayswater Vehicles Ltd

H20210067

21 June 2021 – REVISION A

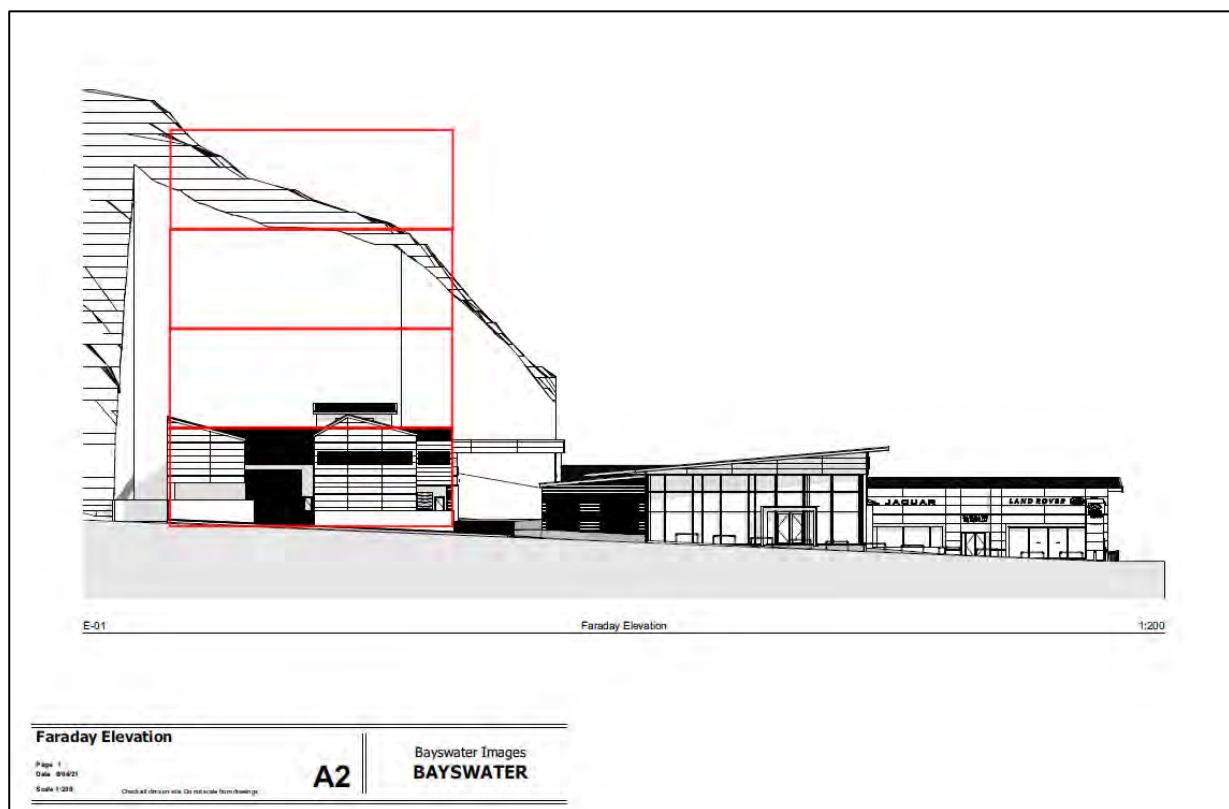
It may be true that the proposed earthworks will be partially mitigated by the existing and proposed built form, however the overall extent of cut is 2 ½ - 3 times larger in scale. See below earthworks and built form comparison diagrams.

Figure 1 – scale comparison earthworks vs. built form.

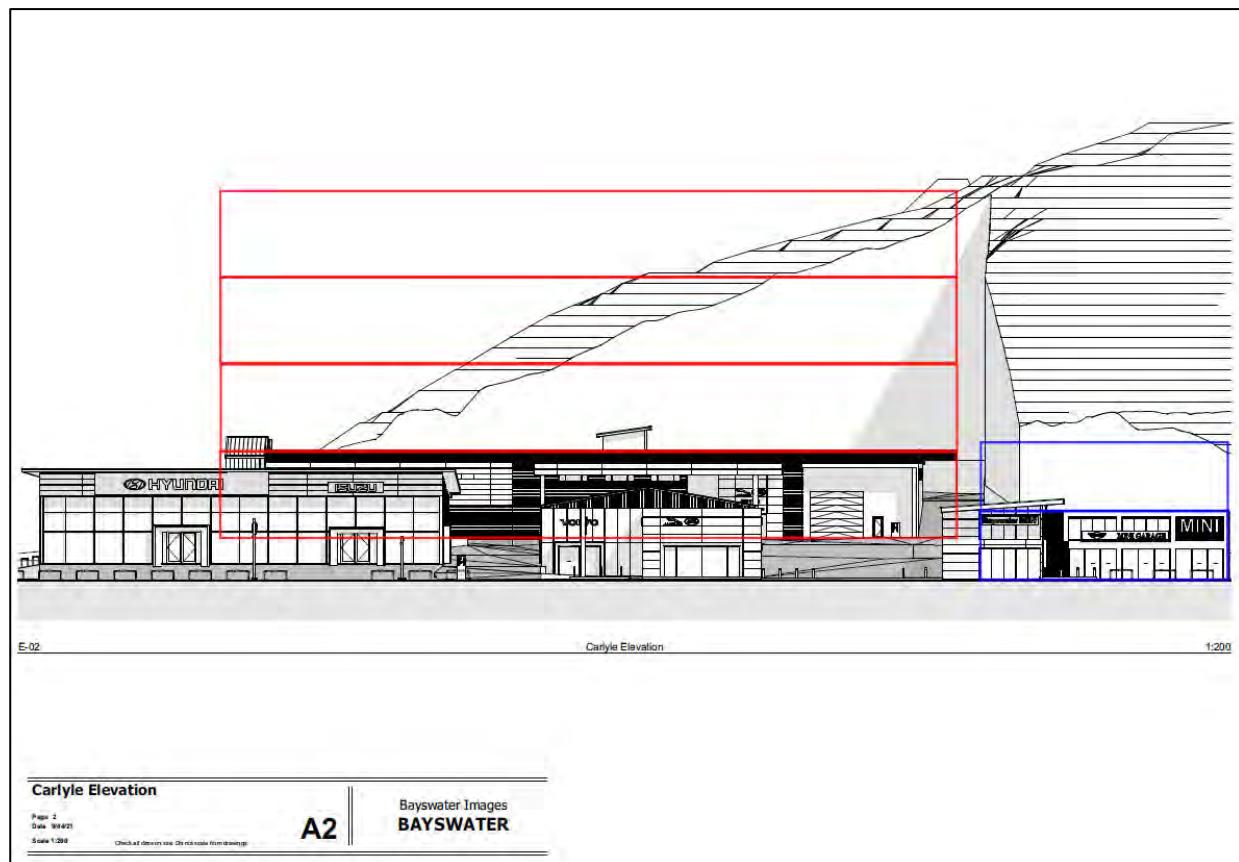
Figure 2 – scale comparison earthworks vs. built form.

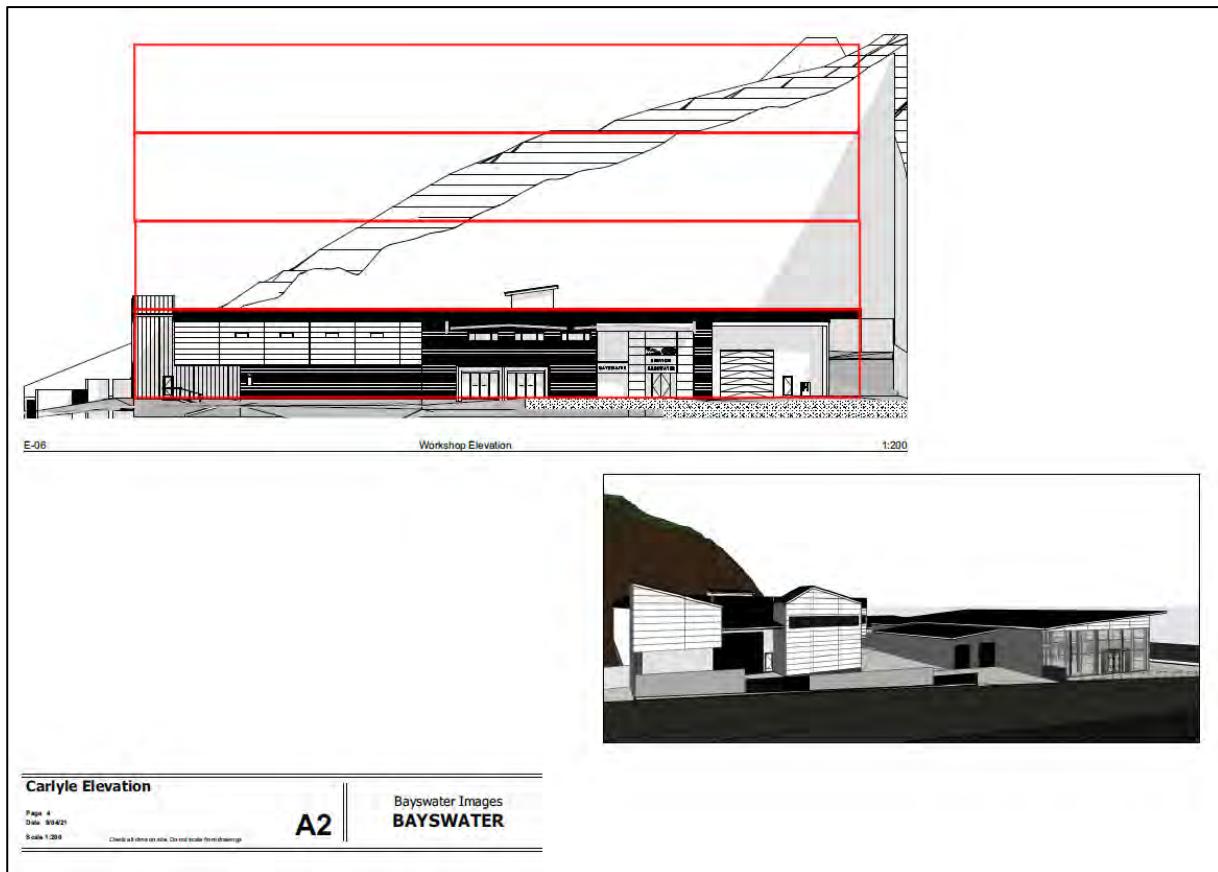
Figure 3 – scale comparison earthworks vs. built form.

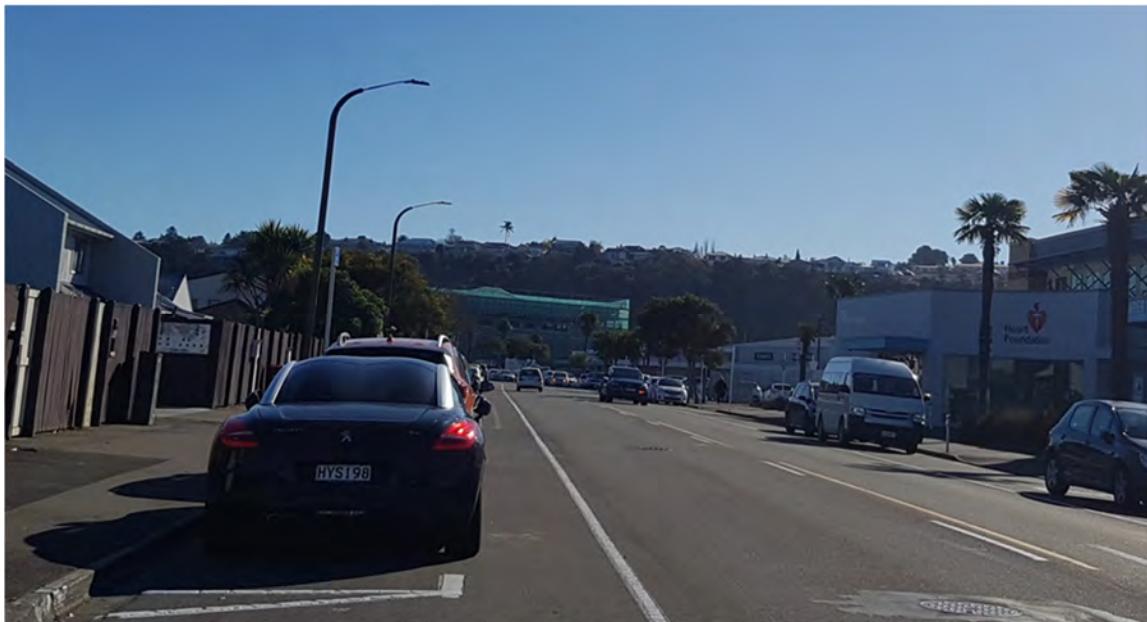
Figure 1 – View from approximately 51 Wellesley Rd Opposite Napier Heath Centre – 700m from the site (not visible in this image). Extent of vegetated band across the face of Mataruahou clear in image providing example of contextual character and amenity of Napier.

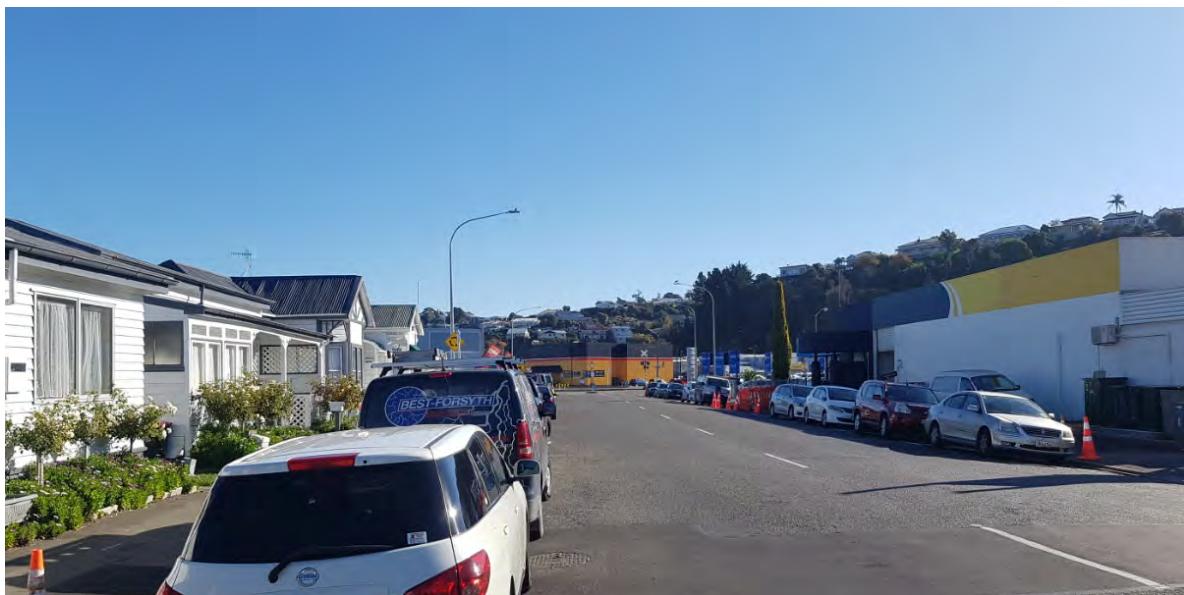
Figure 2 – view from approximately 15 Wellesley Rd – 370m from the site. (Vantage 9 of the DGSE LVA) Wilding pine next to May Avenue visible in this vantage. Repco Building and Owen Street Honda blocking view of Bayswater Buildings. Extent of vegetated band across the face of Mataruahou clear in image. Guys Hill Road dwellings and May Ave clearly visible providing example of residential grain and character of Napier Hill Character Zone.

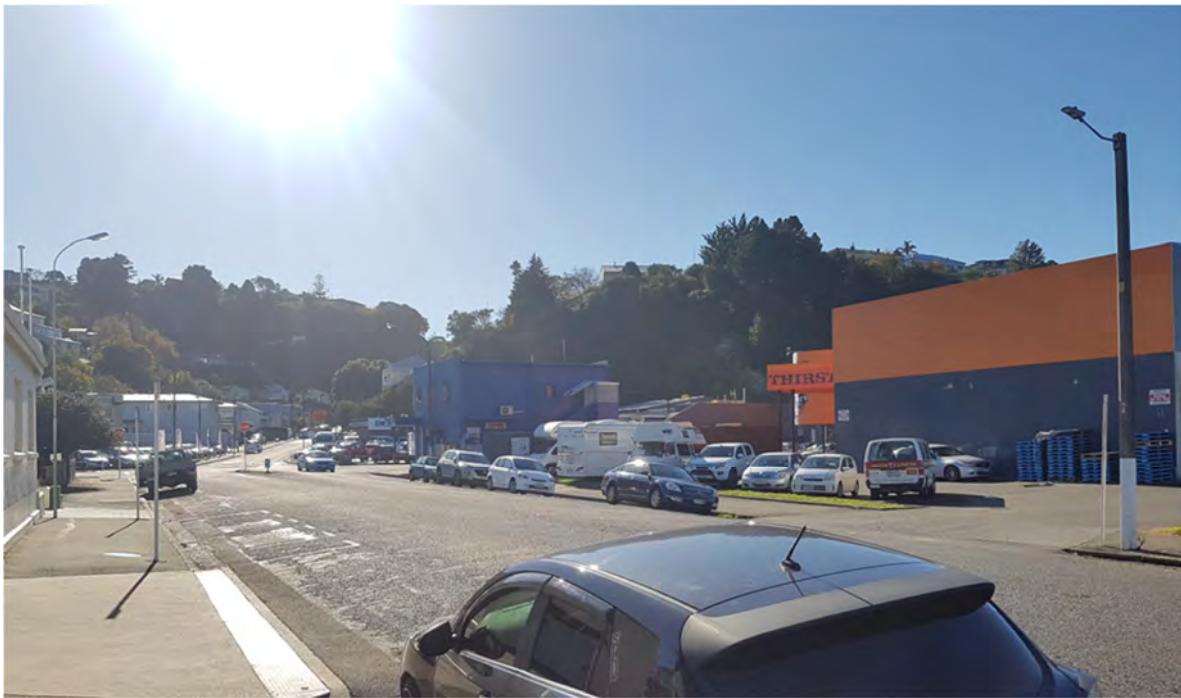
Figure 3 – view from approximately no. 2 Faraday Street (Southern end towards Jull Street) – 80m from the site. (Vantage 8 of the DGSE LVA) Earthworks will be clearly visible from this vantage. The New buildings will be seen also at glimpses through existing built form within Commercial Zone. Bulk of the forecourt and buildings blocked from view by the Carlyle Corner Store and Thirsty Liquor. Extent of vegetated band clear in image behind the commercial zoning. The transition from Commercial to Napier Hill Character Zone is visible through the change of building scale, grain, form and character starting on Faraday Street. The Residential dwellings interspersed between the vegetation is a defining character of Matarauahou.

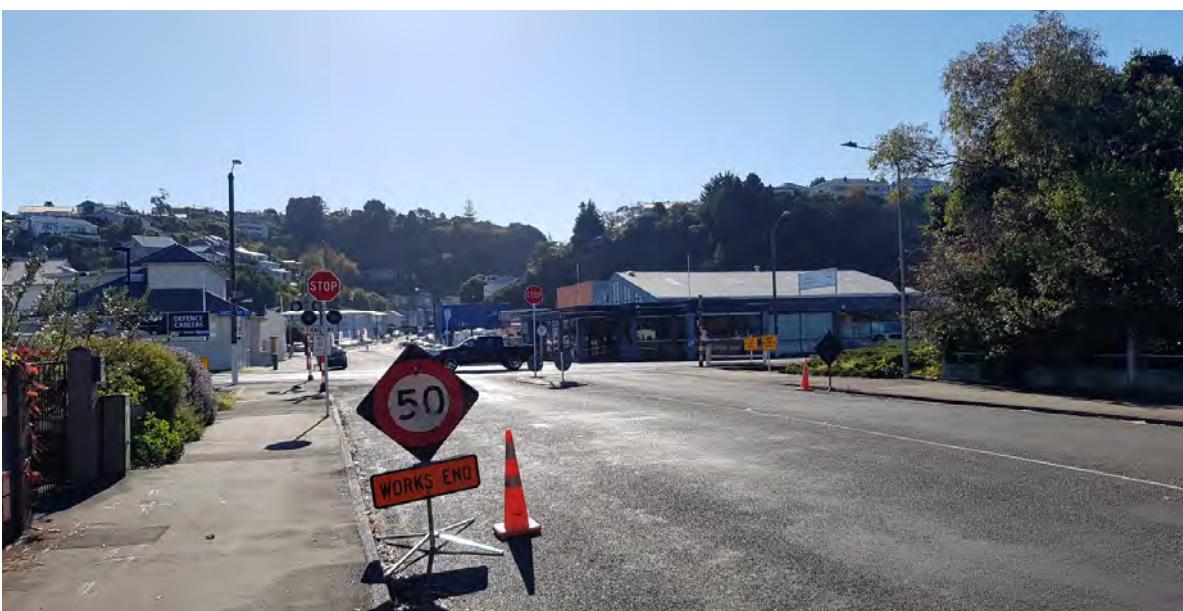
Figure 4 – view from approximately 4 Jull Street – 170m from the site. Earthworks will be clearly visible from this vantage as the cut will reach the dwellings on May Ave visible on the crest above the site. View of the new buildings in the Commercial Zone is obscured by the Carlyle Corner Store and Faraday Street and the buildings in the foreground on Thackeray Street. The transition from Commercial to Napier Hill Character Zone is visible through the change of building scale, grain, form and character starting on Faraday Street. The Residential dwellings interspersed between the vegetation is a defining character of Mataruahou.

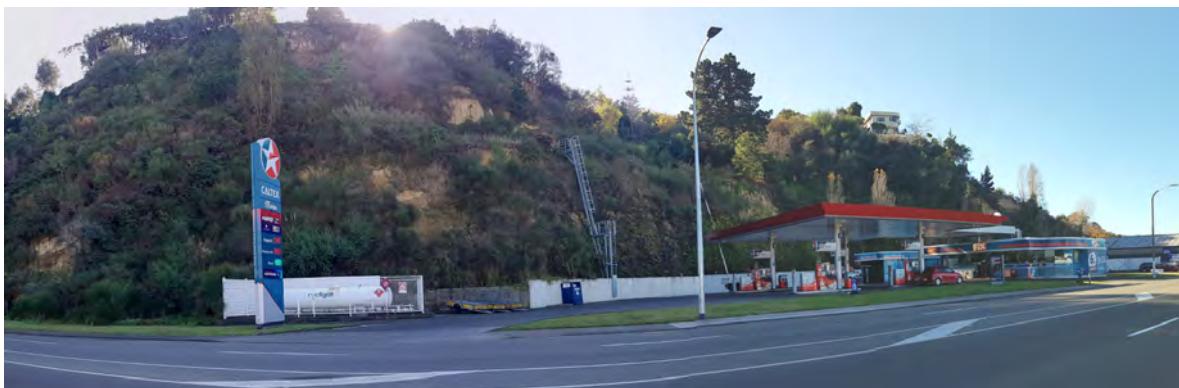
Figure 6 - Panoramic of hill face (from approximately 11 Hyderabad Road) - highlighted in Hudson LVA because a 15m high bench was cut into this face. It is unclear from this image how much of the face was removed when the bench was cut. It however does not seem to materially similar to the large cut of the project site, more of a shave of the face.

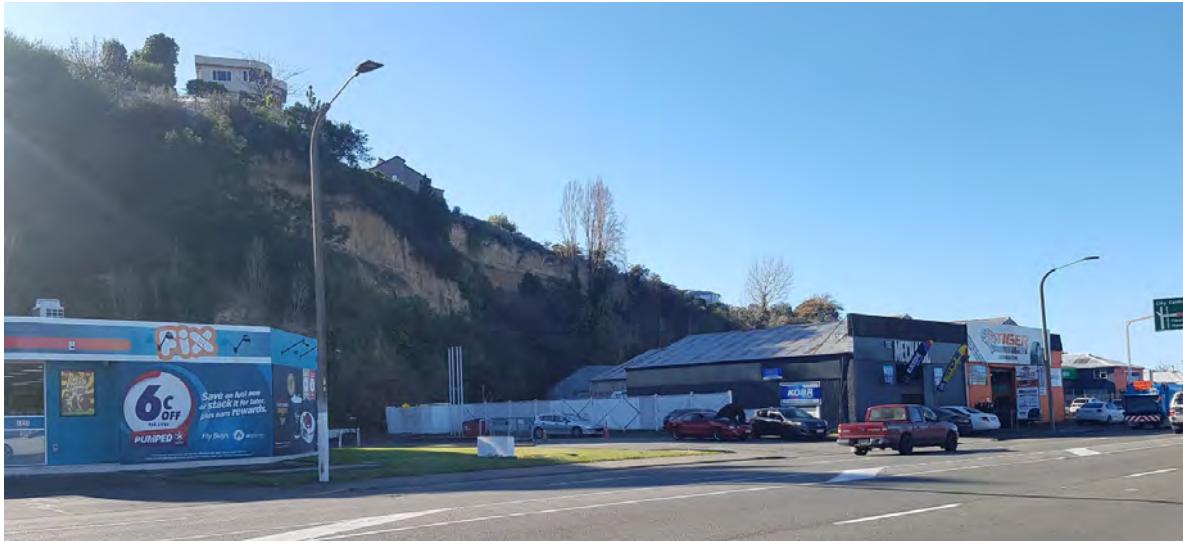
Figure 7 – view of hill face at approximately 7 Hyderabad Road - highlighted in Hudson LVA Stating that the “30m backdrop to Smith & Smith appears to have been excavated with the result being a few open faces of exposed earth and extensive re-establishment of vegetation.” Here the vegetation is from spill over from the more relaxed grades at the top of the cut and canopy cover from trees and vegetation grown from the toe of the hill. The face of this cut also looks as though it is undercutting near the top and may be unstable. Council would better know the background of any earthworks undertaken in this location.

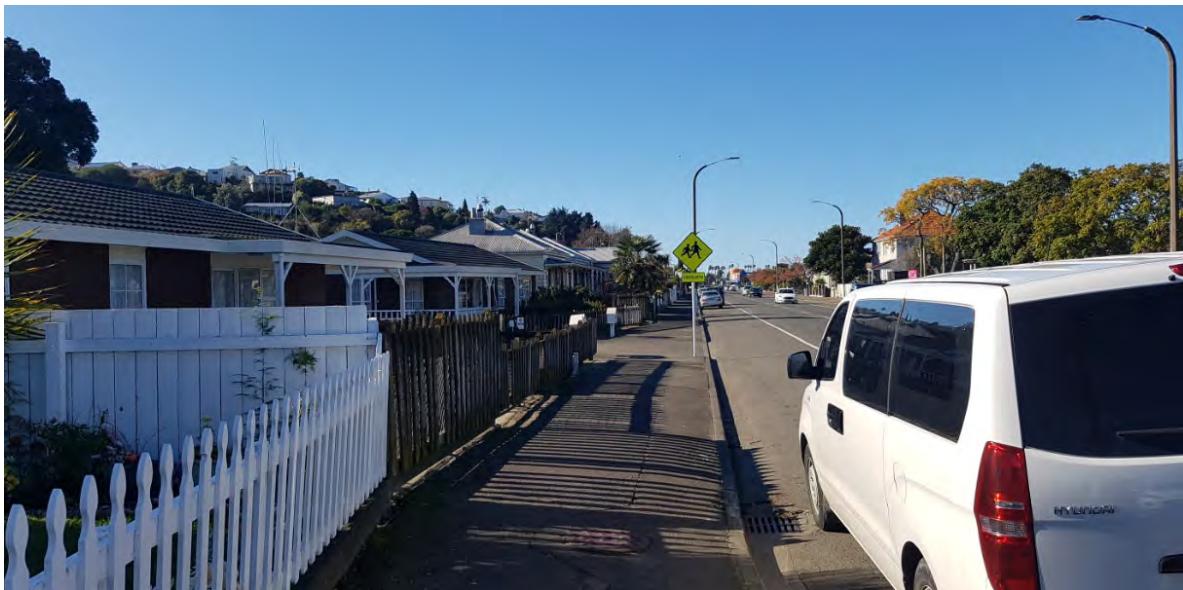
Figure 8 – View from approximately 201/199 Carlyle Street – 400m from the site. Earthworks will not be visible from this location. Some vegetation will be affected such as the wilding pines that may have to be removed as a hazard anyway which are visible.

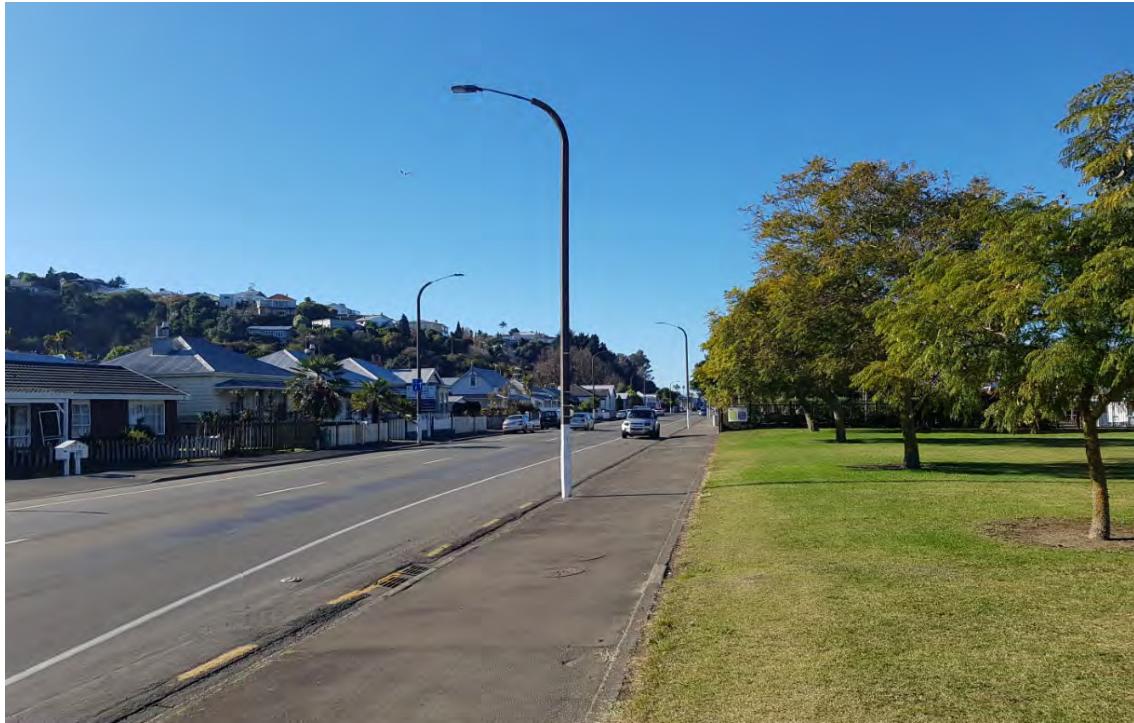
Figure 9 – View from Municipal Reserve Carlyle Street – 390m from the site. Earthworks will be visible from this location – vegetation removal will be visible from this location.

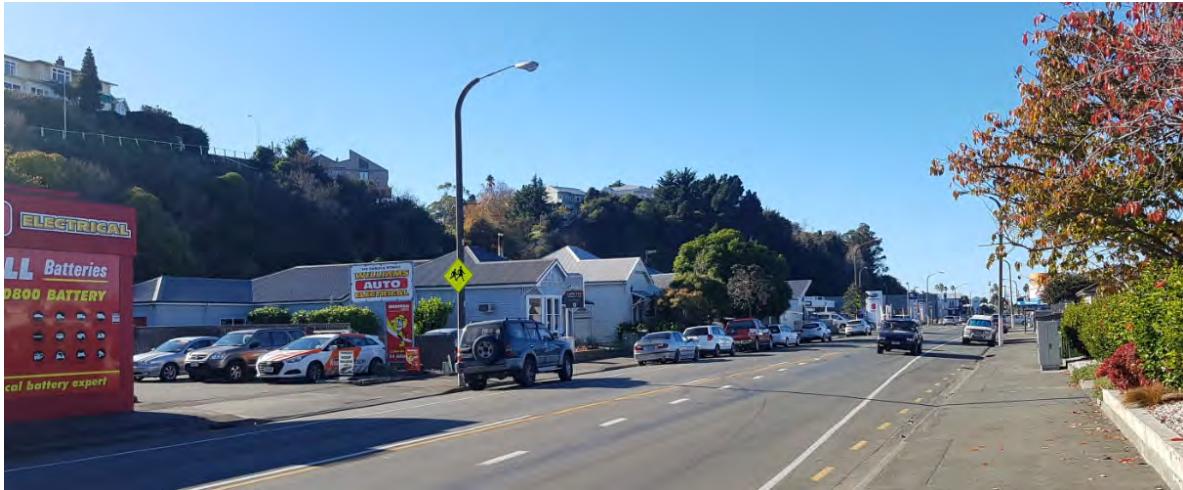
Figure 11 - view from 148 Carlyle Street – 150m from site – (Vantage 7B of the DGSE LVA) vegetation removal and earthworks will be visible.

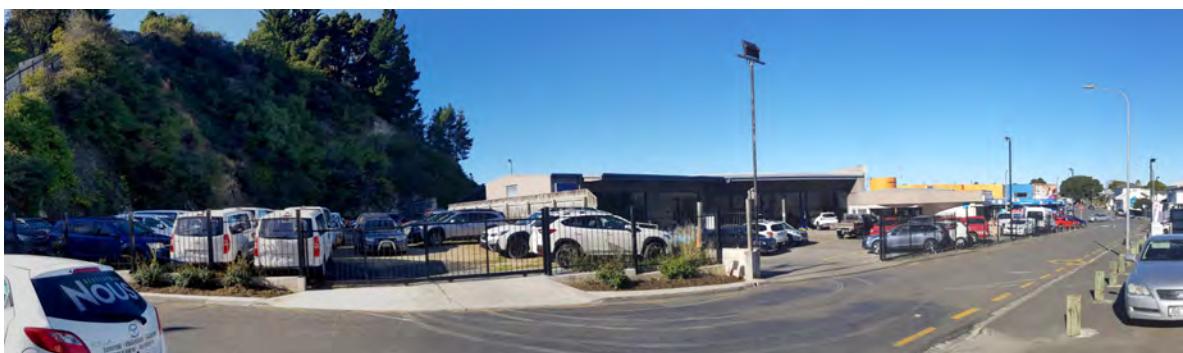
Figure 12 – Panoramic view from 10 Faraday Street – 10m from site – view of workshop and at grade car park. Workshop open to view of residential buildings. Proposed workshop building conceals this activity. Existing relaxed grade cliff face visible from this view.

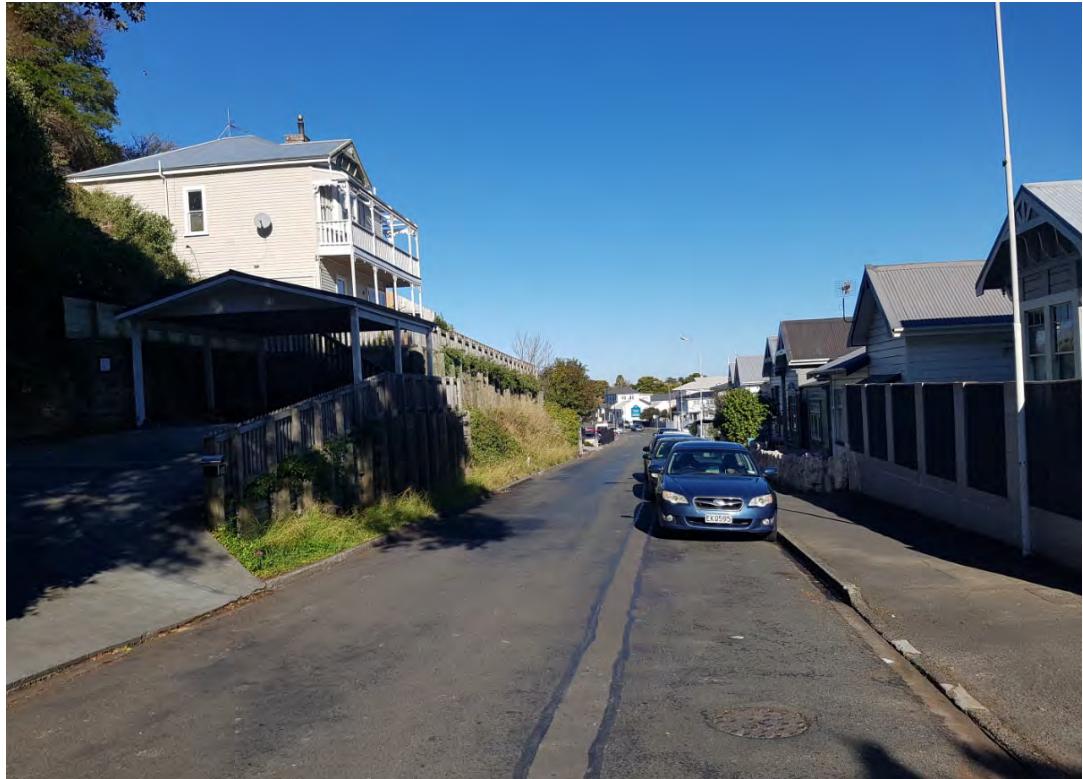
Figure 18 - View down Faraday Street at approximately fronting 20/ 22 Faraday Street (Vantage 4 of the DGSE LVA) – view of the proposed site is obscured by the retaining of 33 Faraday Street – roof line of the new workshop could be visible from this vantage.

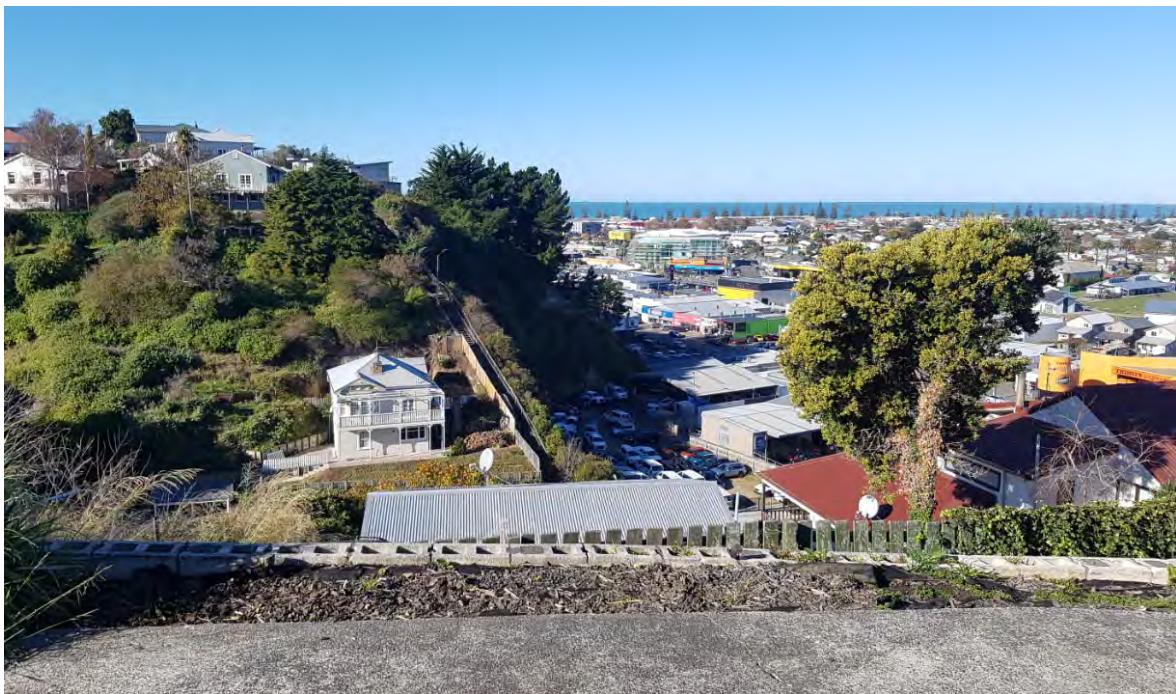
Figure 21 - View from 14 Guys Hill Road car park – site and earthworks will be clearly visible from dwelling.

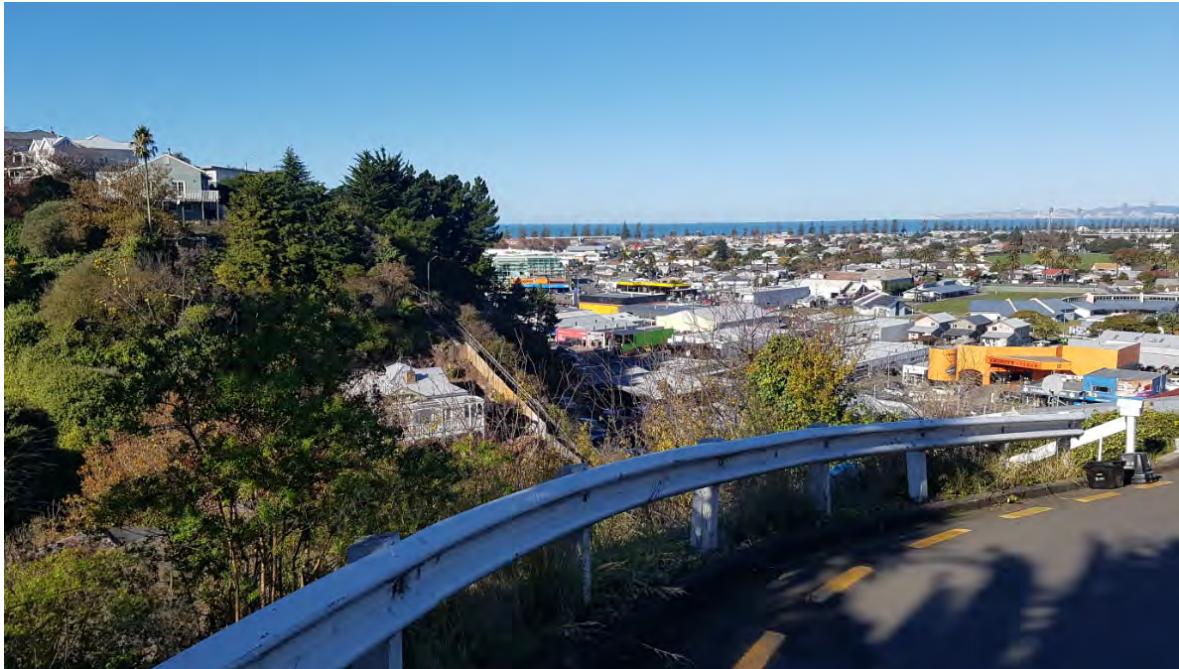
Figure 22 - View from near 11a within road corridor – above 11 Guys Hill Road - earthworks will be clearly visible from the dwelling.

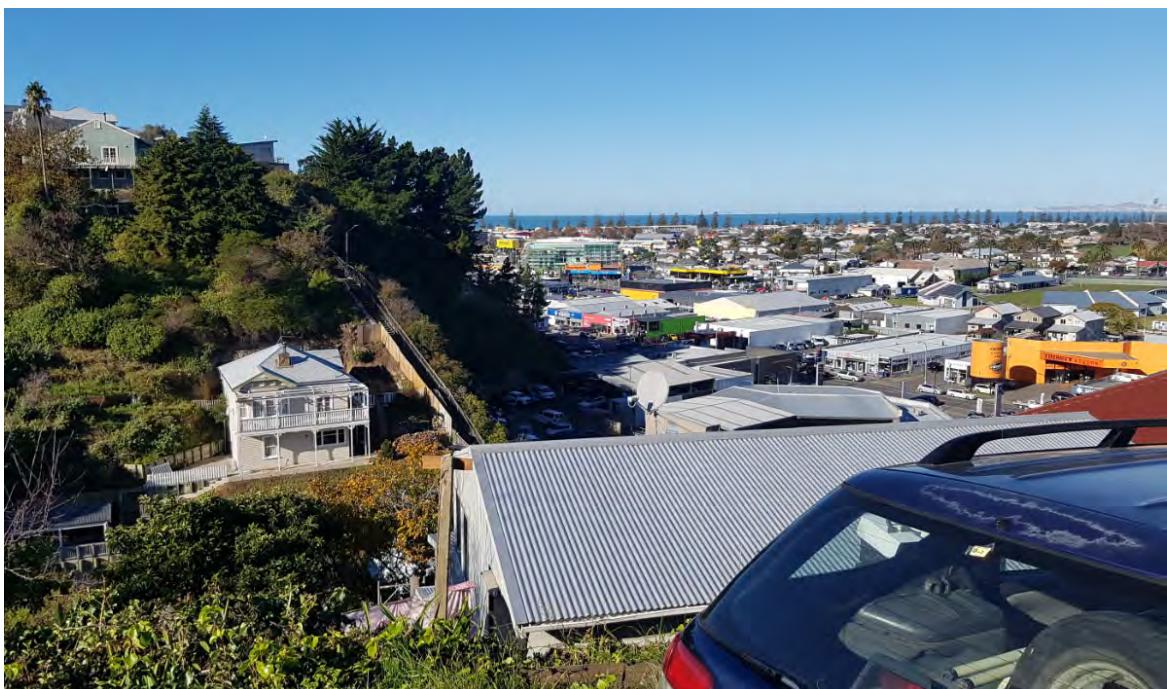
Figure 23 - View on road above 9a and 9c Guys Hill Road (Vantage 7B of the DGSE LVA) - earthworks will be clearly visible from the dwelling.

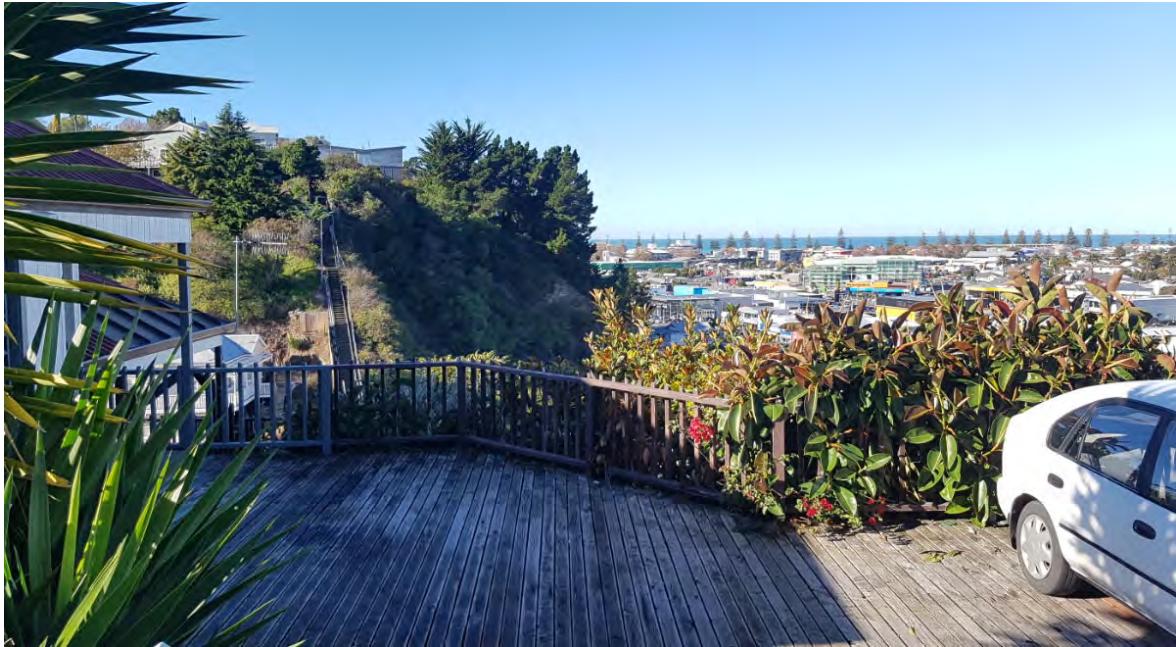
Figure 24 - 7A Guys Hill Road - earthworks will be clearly visible from the dwelling.

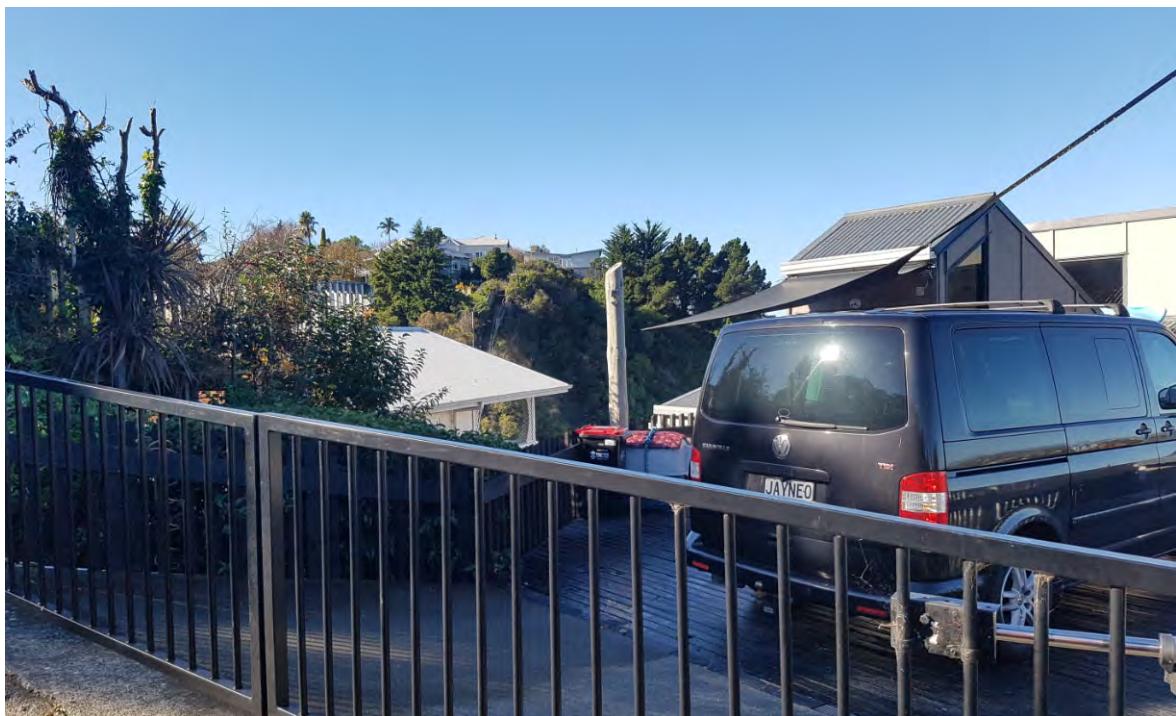
Figure 25 - 5 Guys Hill Road – earthworks will be clearly visible from the dwelling.

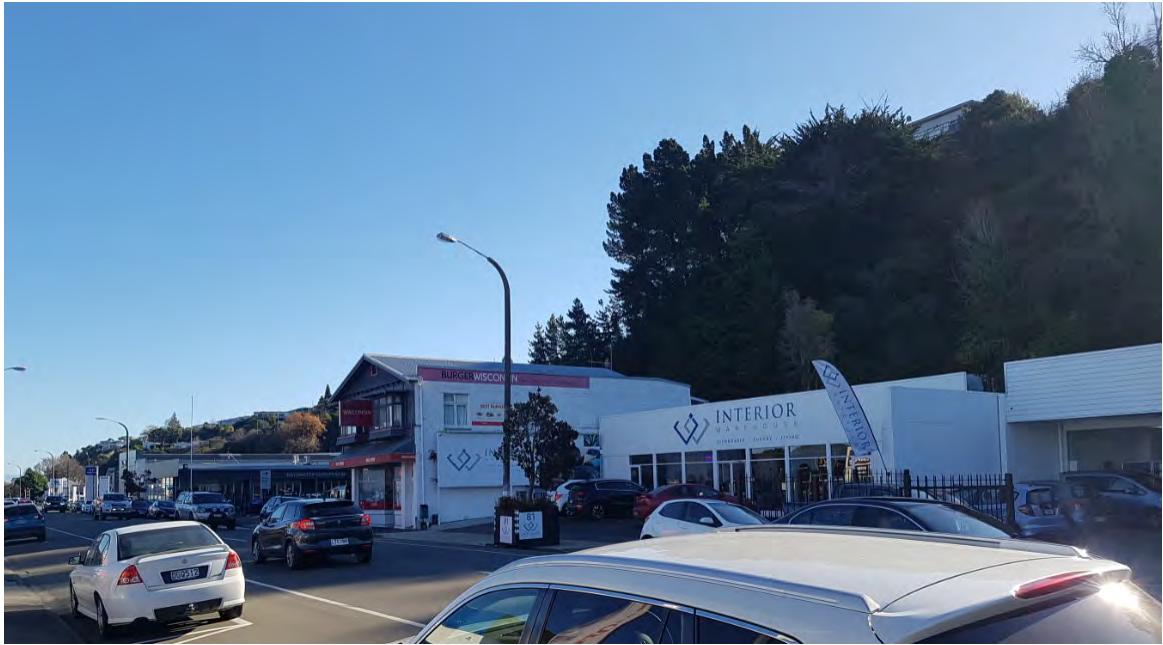
Figure 26 - View from 86 Carlyle Street of site – obscured view of earthworks due to existing buildings – wilding pines will likely be removed due to earthworks. Façade of new building will be visible on the left of Burger Wisconsin.

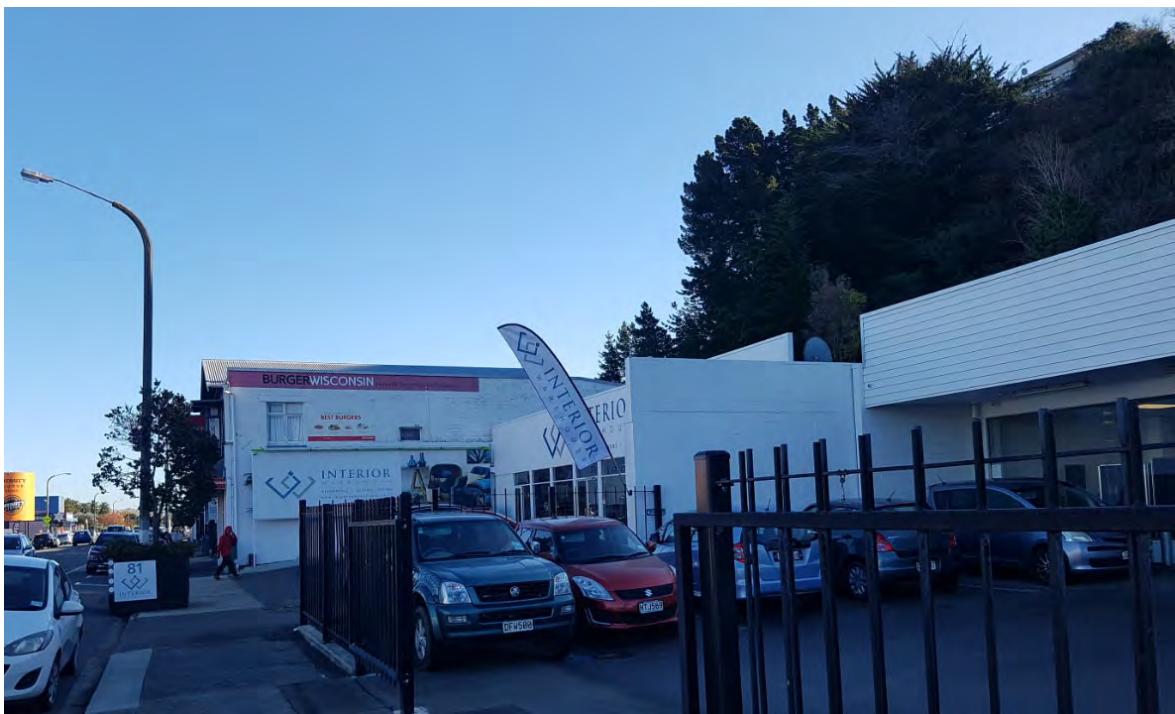
Figure 27 - View from 73 Carlyle Street of site – obscured view of earthworks due to existing buildings – wilding pines will likely be removed due to earthworks.

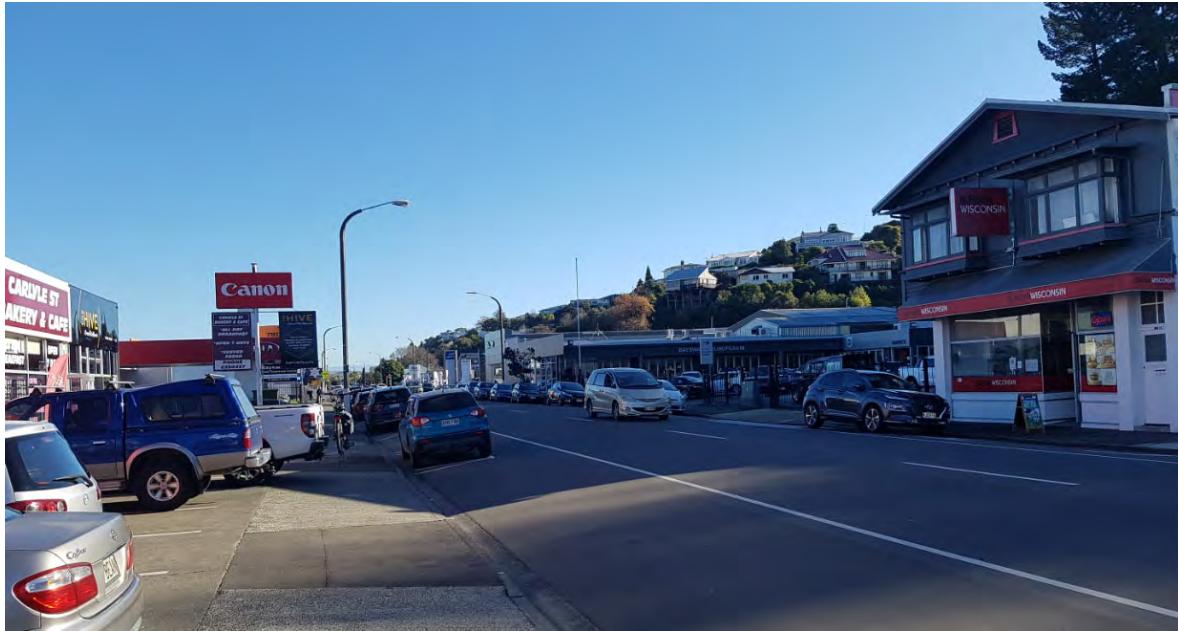
Figure 28 - View from 104 Carlyle Street of site – obscured view of earthworks due to existing buildings – wilding pines will likely be removed due to earthworks.

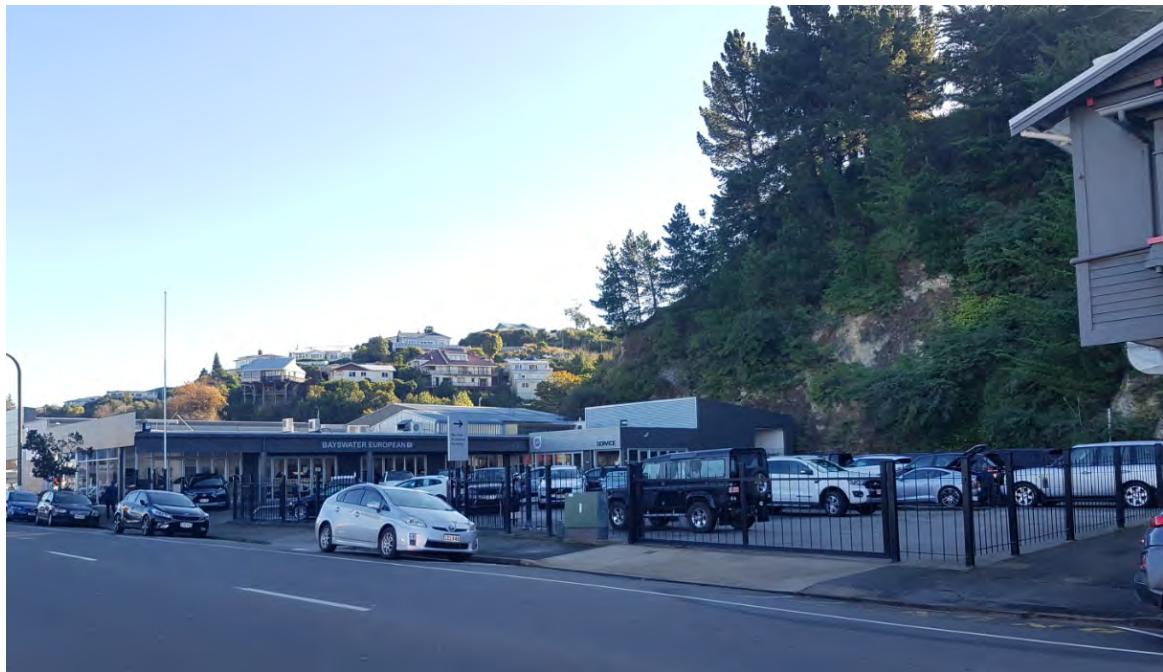
Figure 29 - View from 110 Carlyle Street of site – smaller wilding pines on bottom of slope will be the base of the earthworks cut as well as smaller cut to visible face for new building to be located in foreground of yard. Large pines will likely be removed due to instability. Scale of proposed building will obscure half the height of the cut on this face.

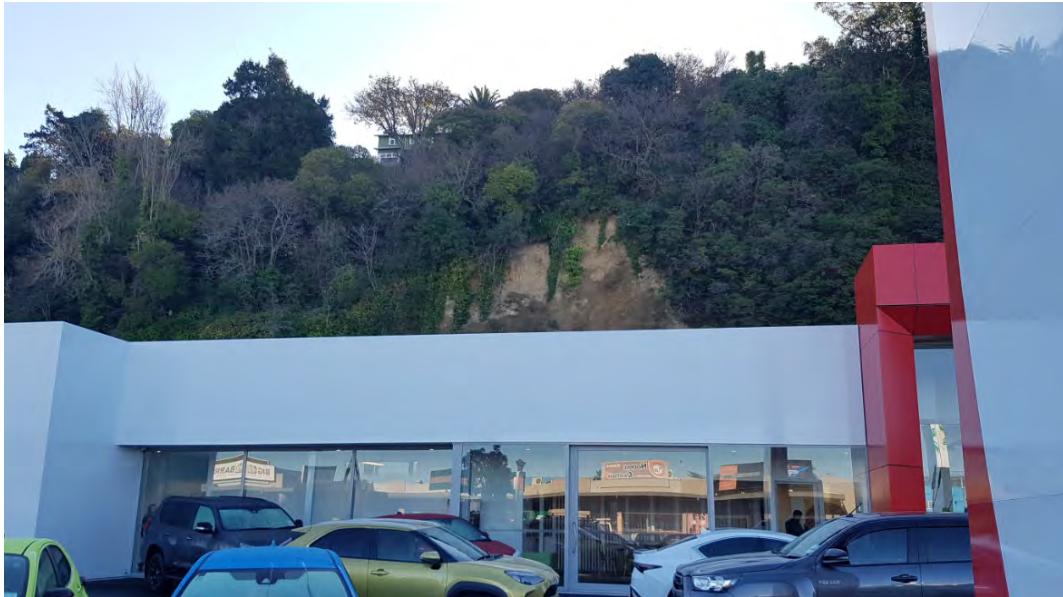
Figure 30 - Hawkes Bay Toyota 49 Carlyle Street – Shows vegetation on the gentler grade at the top with climbers spilling over the edge of the almost vertical cut face. Viewing audience like that of the project site as on same street.

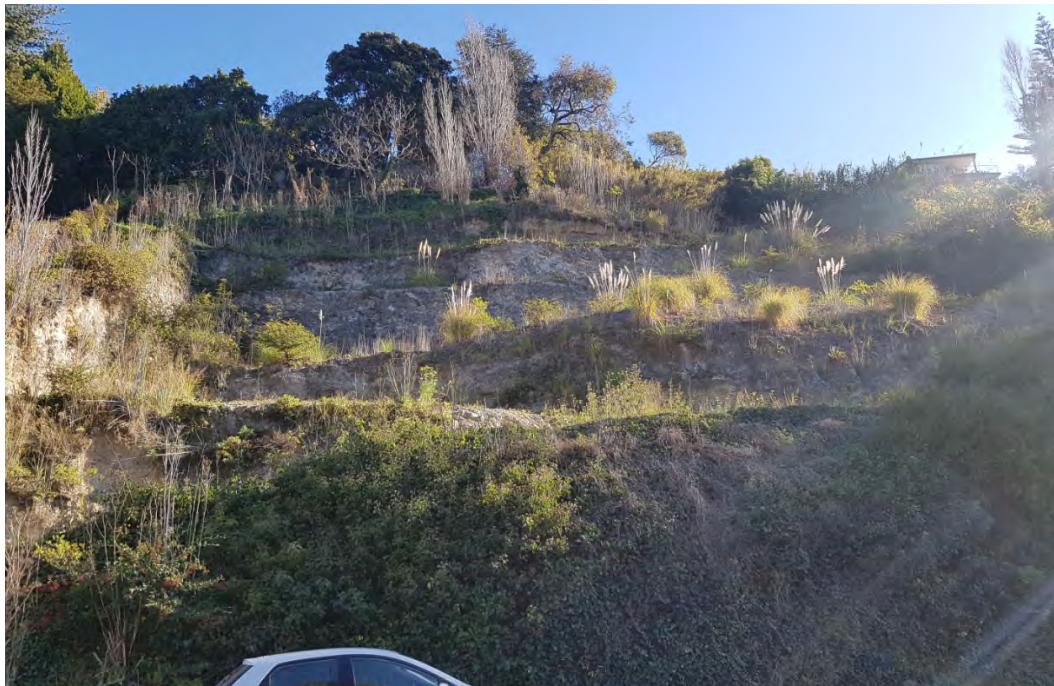
Figure 31 - 108 and 108A Shakespeare Road – Cut terraces showing sporadic revegetation. Again, cut faces remain sparsely covered. Limited viewing audience. Limited viewing audience mainly transient vehicle and static views from neighbouring dwellings.

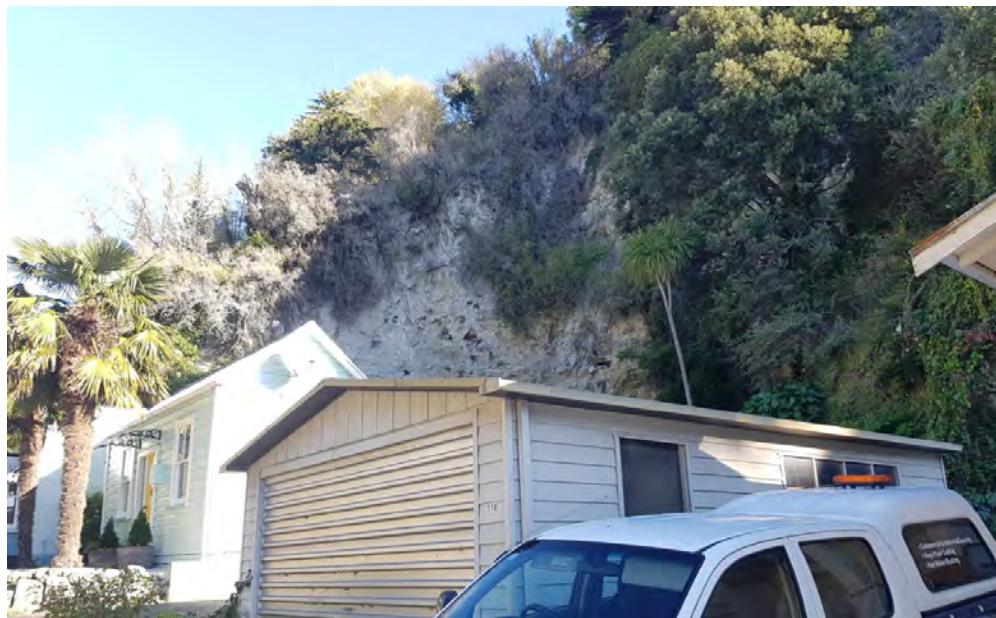
Figure 32 - 114-118 Shakespeare Road – Cut face showing sporadic revegetation. Again, cut faces remain sparsely covered, mainly gaining cover from vines and climbers spilling over the top from softer gradients. Also visible are pigeonholes. Limited viewing audience mainly transient vehicle and static views from neighbouring dwellings.

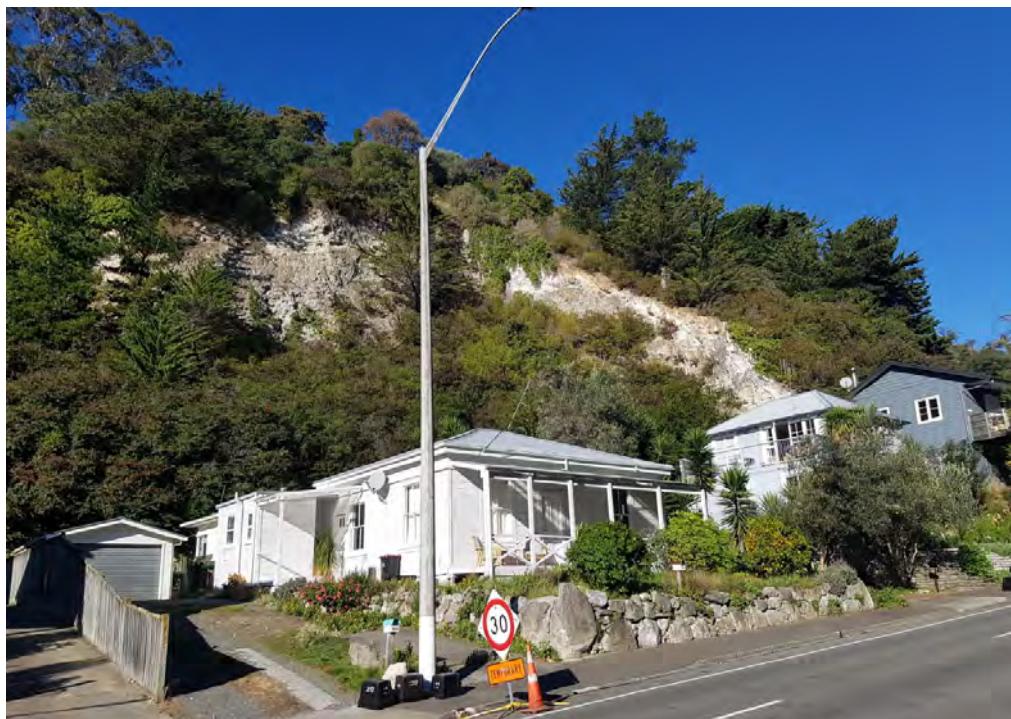
Figure 33 - 157-165 Shakespeare Road – older weathered face – almost vertical cuts show no vegetation – white in colouring. Limited viewing audience mainly transient vehicle and static views from neighbouring dwellings.

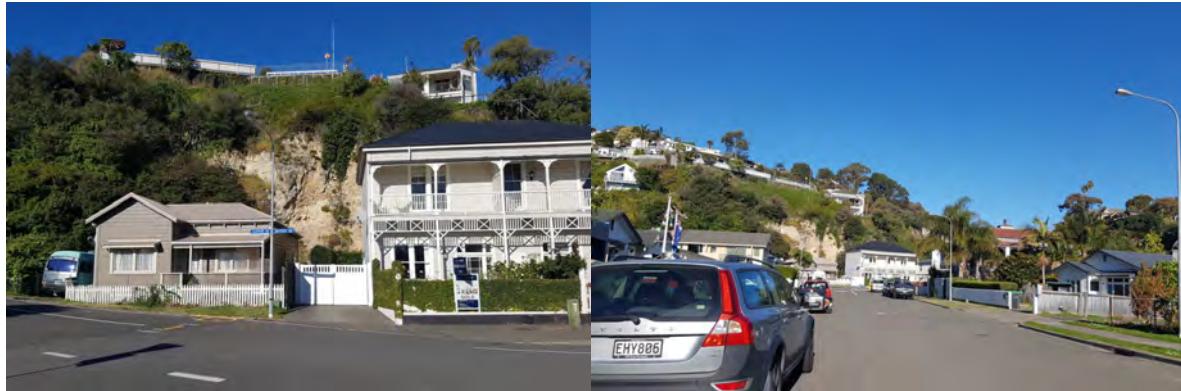
Figure 34 - 45 Seapoint Road and 8 Battery Road – Example given in LVA - Vertical cut unvegetated – clearly visible down the end of perpendicular Battery Road (photo taken at head of road near 8 Battery Road/Breakwater Road Entry 100m from cut face). Larger viewing audience due to proximity to coastal motorways and more intersecting streets. Mainly transient vehicle and static views from neighbouring dwellings.
