LANDSCAPE PEER REVIEW

Bayswater Vehicles Ltd

H20210067

21 June 2021 – REVISION A

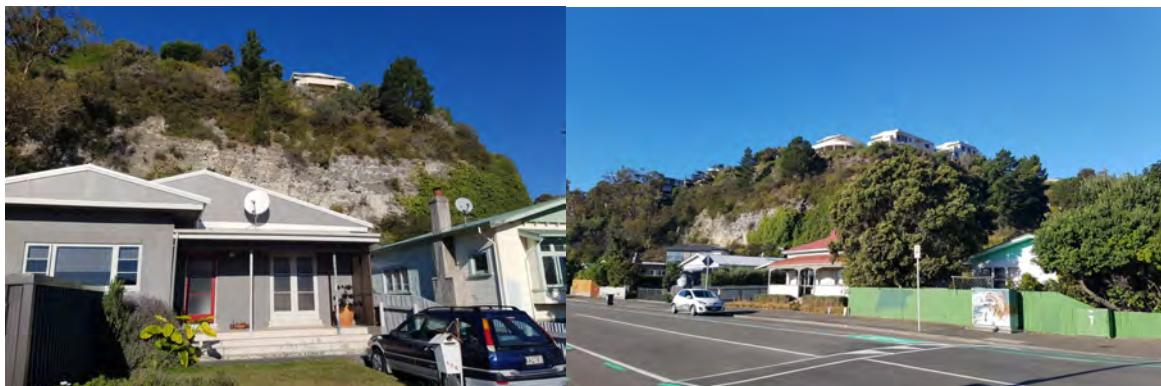
Figure 35 - 108 Battery Road – Example given in LVA – unvegetated vertical cut face – vegetation spilling down the batter from the top terrace. Larger viewing audience due to proximity to coastal motorways and more intersecting streets. Mainly transient vehicle and static views from neighbouring dwellings.

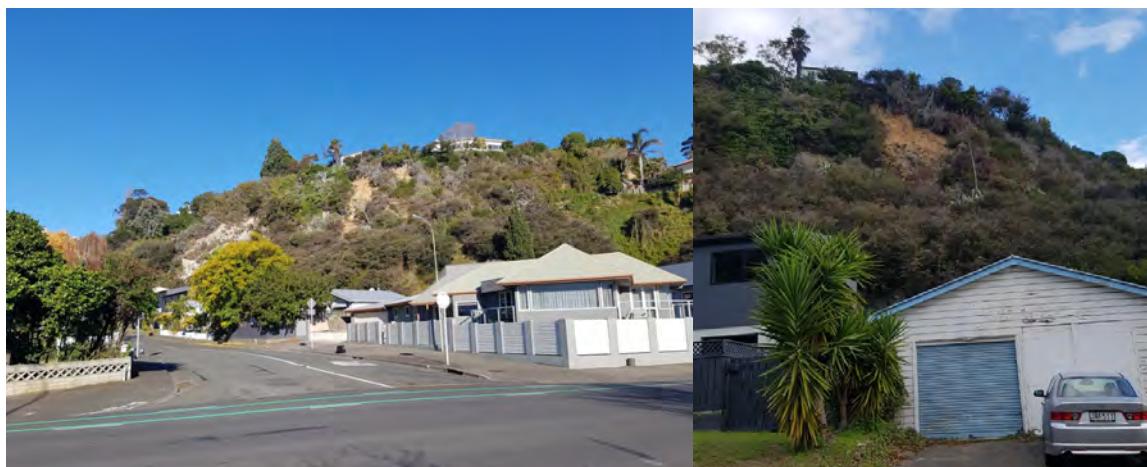
Figure 36 – example given in Cheal report – 78 Burns Road visible cut on left of image, vegetation patchy on vertical cut face. Slip face shown centre image above garage at 50 Burns Road. Larger viewing audience due to proximity to coastal motorways and more intersecting streets. Mainly transient vehicle and static views from neighbouring dwellings.

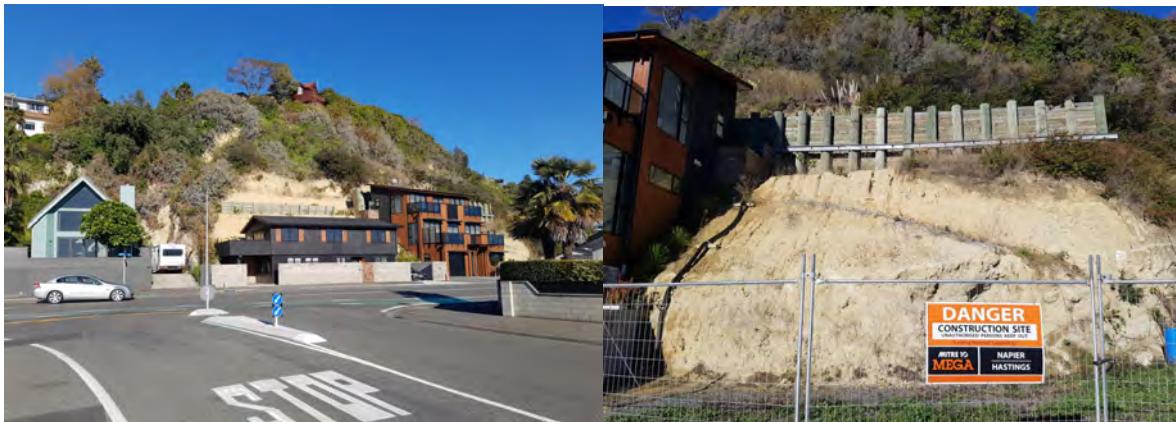
Figure 37 – 138 and 140 Battery Road – earthworks undertaken for new dwellings. Half the hill face removed to allow dwellings to be built into the cliff face. Half the face remains untouched and existing vegetation retained.

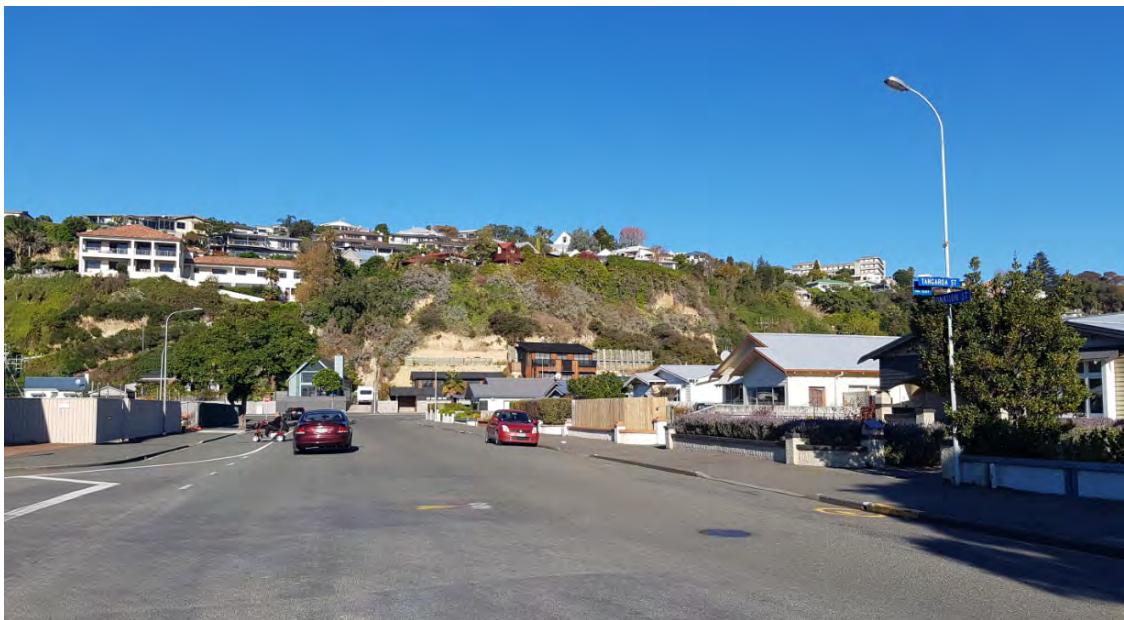
Figure 38 - View of 138 and 140 Battery Road from 3 Coronation Street. 160m away from cut. Example that cut face is visible from a distance. Vegetated band visible around the perimeter of Matarauhou and is a strong amenity value and character of Napier.

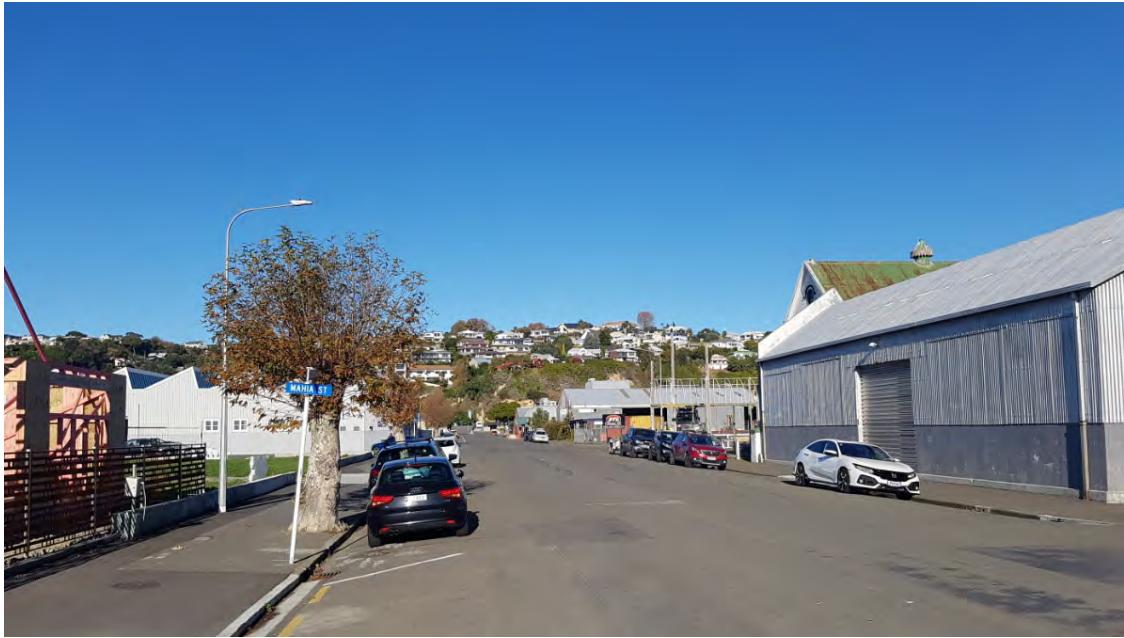
*Figure 39 - View of 138 and 140 Battery Road from 25 Coronation Street – 370m from cut face.
The above series of images DNL believe is a good example of a similar scale face and built form comparison; the cut made for these dwellings is mitigated by the built form – if however, the whole face of the cliff above the dwelling were removed the visual effect would be much more significant. It is also example of the significant character that the band of vegetation that wraps around the hill provides. If the proposed earthworks (27m high) we transposed onto this face it would essentially remove a large portion of this face right up to the top terrace of houses, which would be highly visible from within the contextual landscape.*

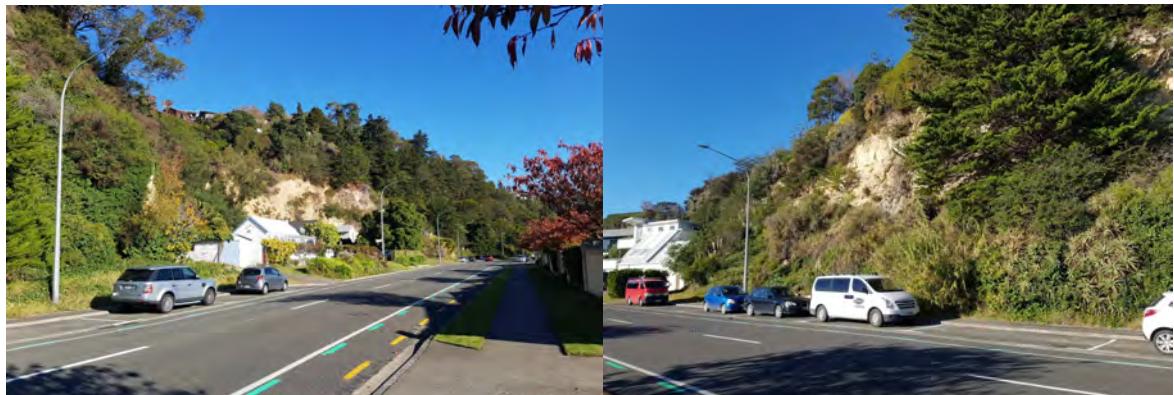
Figure 40 – exposed face near 160 Battery Road – vertical faces devoid of vegetation, the more relaxed grades near the crest of the hill are vegetated. Vegetated band clearly visible between toe of the hill and crest.

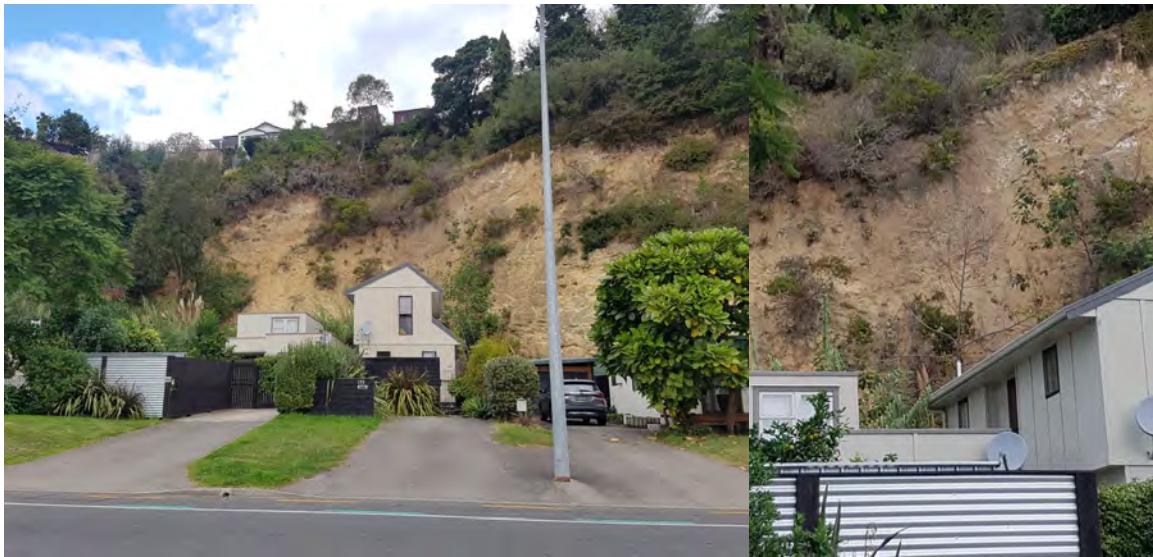
Figure 41 – 170 Battery Road – Rock mesh is visible behind the dwellings here – the vertical cliff face is shows limited vegetation cover.

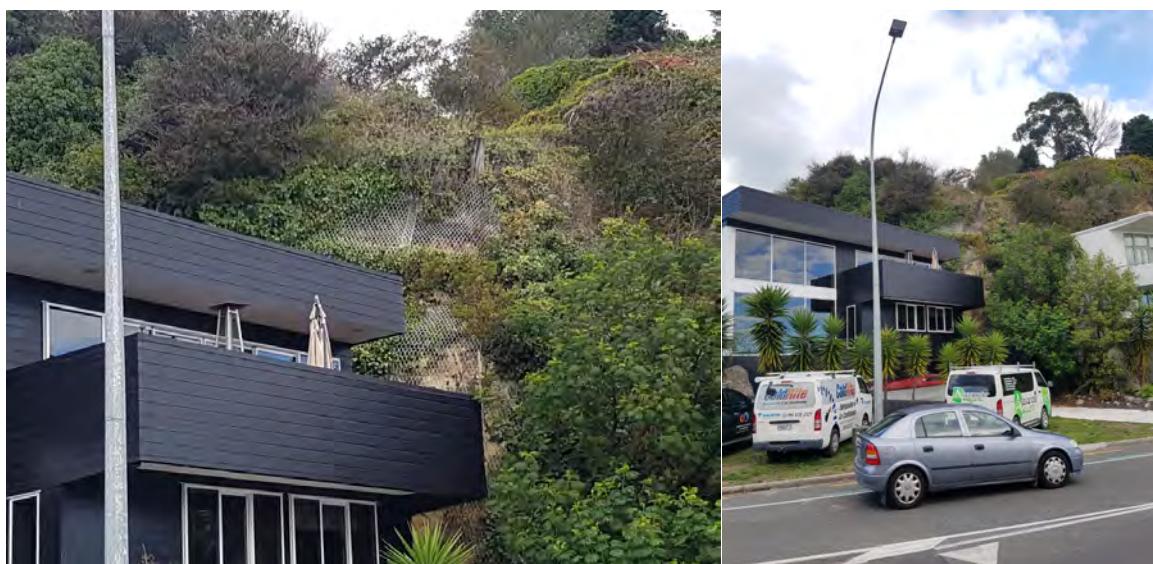
Figure 42 – 160 Battery Road – Rock fall mesh is visible behind the dwelling on the steeper face of Mataruahou. Visual impact is mitigated here largely by the built form and existing vegetation on the face of the hill being maintained.

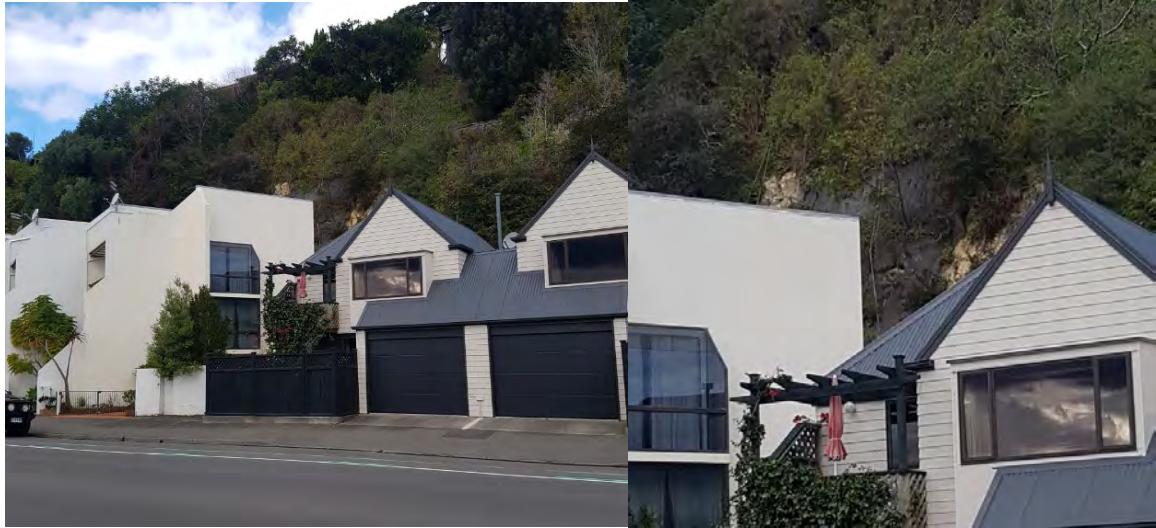
Figure 43 – 55-59 Battery Road has geotextile and geogrid (rock fall mesh) on the face behind the apartment block and from what can be seen vegetation has not taken on the face leaving the geotextiles exposed. This is a potential risk for the earthworks face proposed on the Bayswater site. The slope grade above the roof line of the dwellings relaxes to allow vegetation to spill over the top of the vertical face. Vegetated band visible.

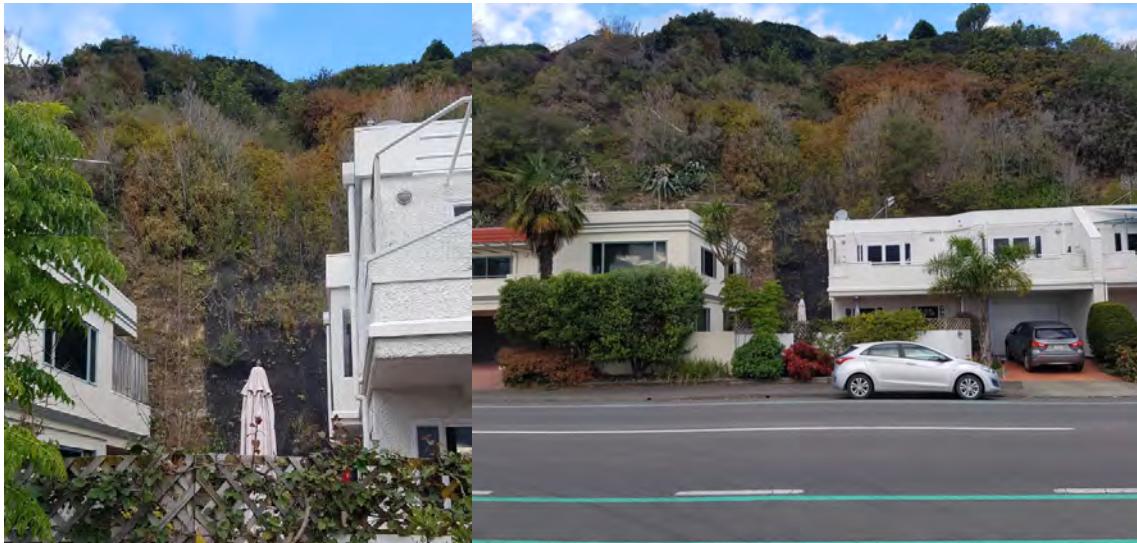
Figure 44 – 78 Battery Road has geotextile and geogrid (rock fall mesh) on the face behind the apartment block and from what can be seen vegetation has not taken on the face leaving the geotextiles exposed. This is a potential risk for the earthworks face proposed on the Bayswater site. Visual impact is largely mitigated at 78 (and 55-59 in fig. 42) Battery Road due to the height and scale of the built form. As above the slope grade above the roof line of the dwellings relaxes to allow vegetation to spill over the top of the vertical face. Vegetated band visible.

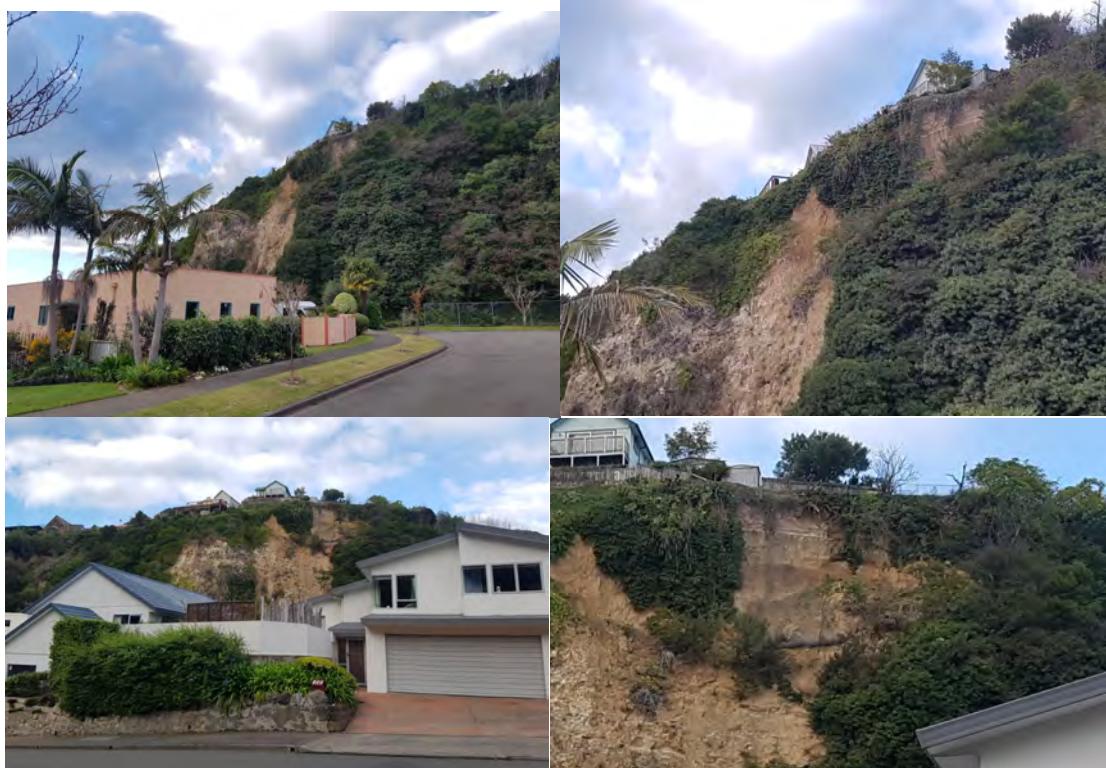
Figure 45 – Amner Place/ Milton Road - The Cheal report notes that Amner Place is a comparison of the type cut design that is a comparison to what has been proposed. Amner place has been quarried in the past leaving relatively steep cut slopes. This face it is now showing signs of slips and rock fall mesh has been draped down from the top slop in an attempt to mitigate this.

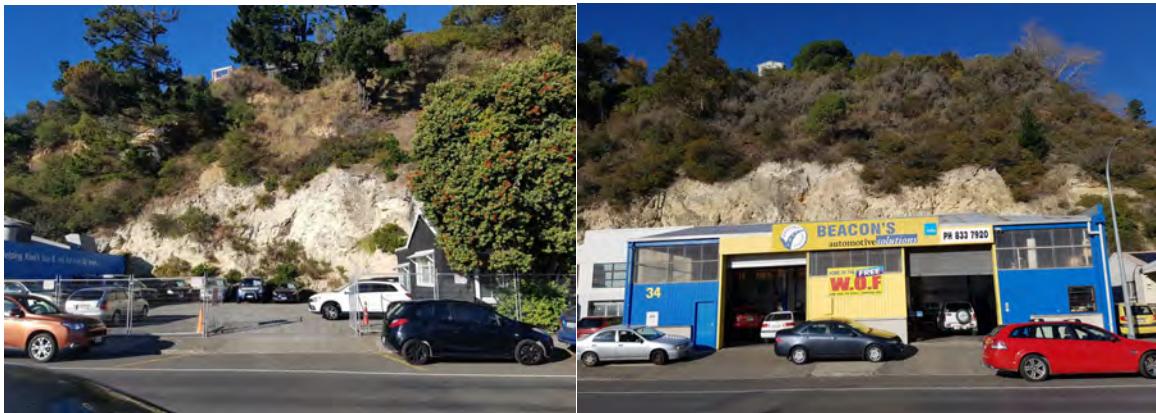
Figure 47 – Caruna Bay – existing cliff faces behind workshops – vegetation sparse on vertical faces but growing on more relaxed face above built form.

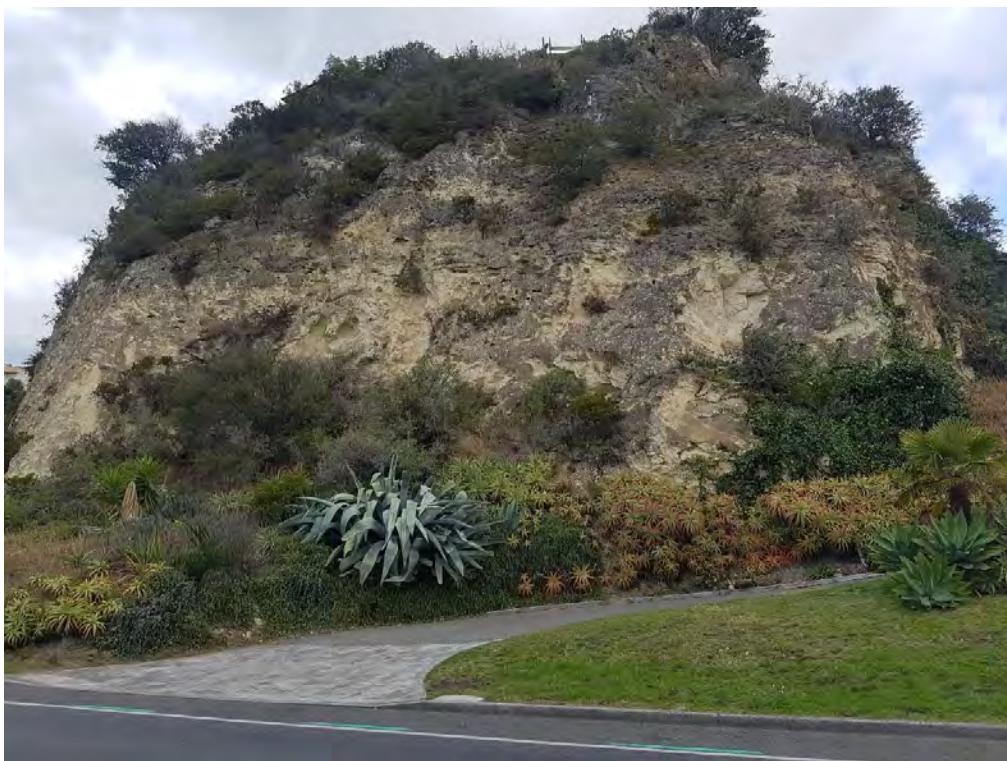
Figure 48 – Hospital Hill cliff face on the corner Battery Road and Hyderabad Road (driveway entry to 210 Battery Road visible) – weathered limestone cliff face with sparse vegetation

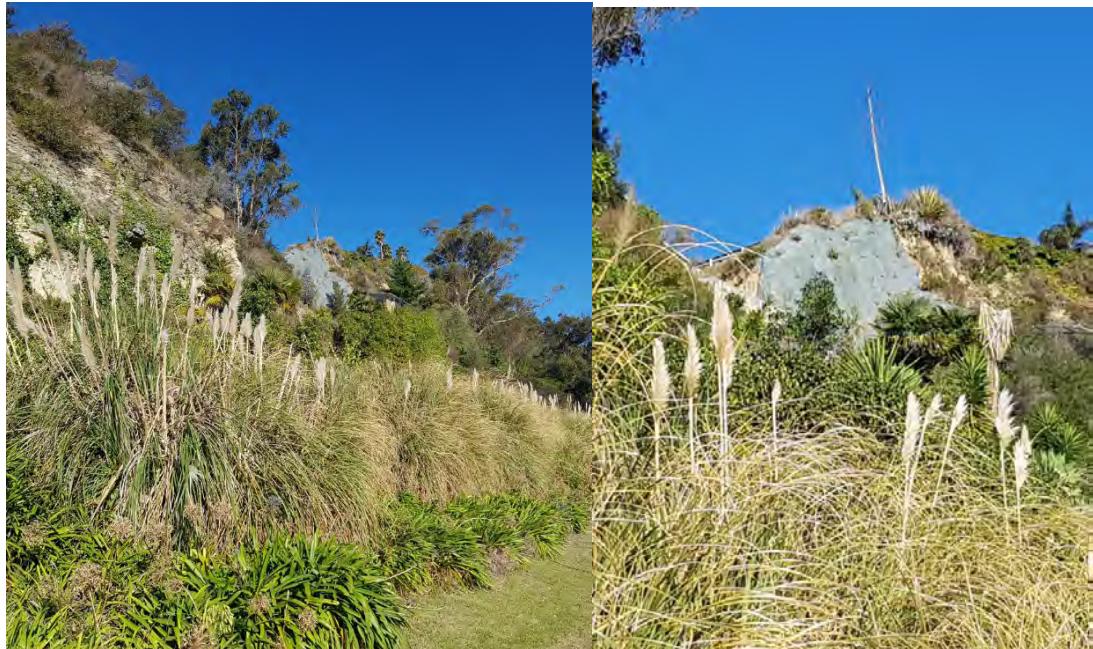
Figure 49 - view of 210 Battery Road – Cut face required concrete stabilisation and anchors.
