**MARIST HOLDINGS (GREENMEADOWS)
LTD MISSION TRUST**

**PRELIMINARY GEOTECHNICAL REPORT
FOR WESTERN HILLS RESIDENTIAL
DEVELOPMENT
PUKETITIRI ROAD, GREENMEADOWS**

REFERENCE NUMBER: 21027

FEBRUARY 2004

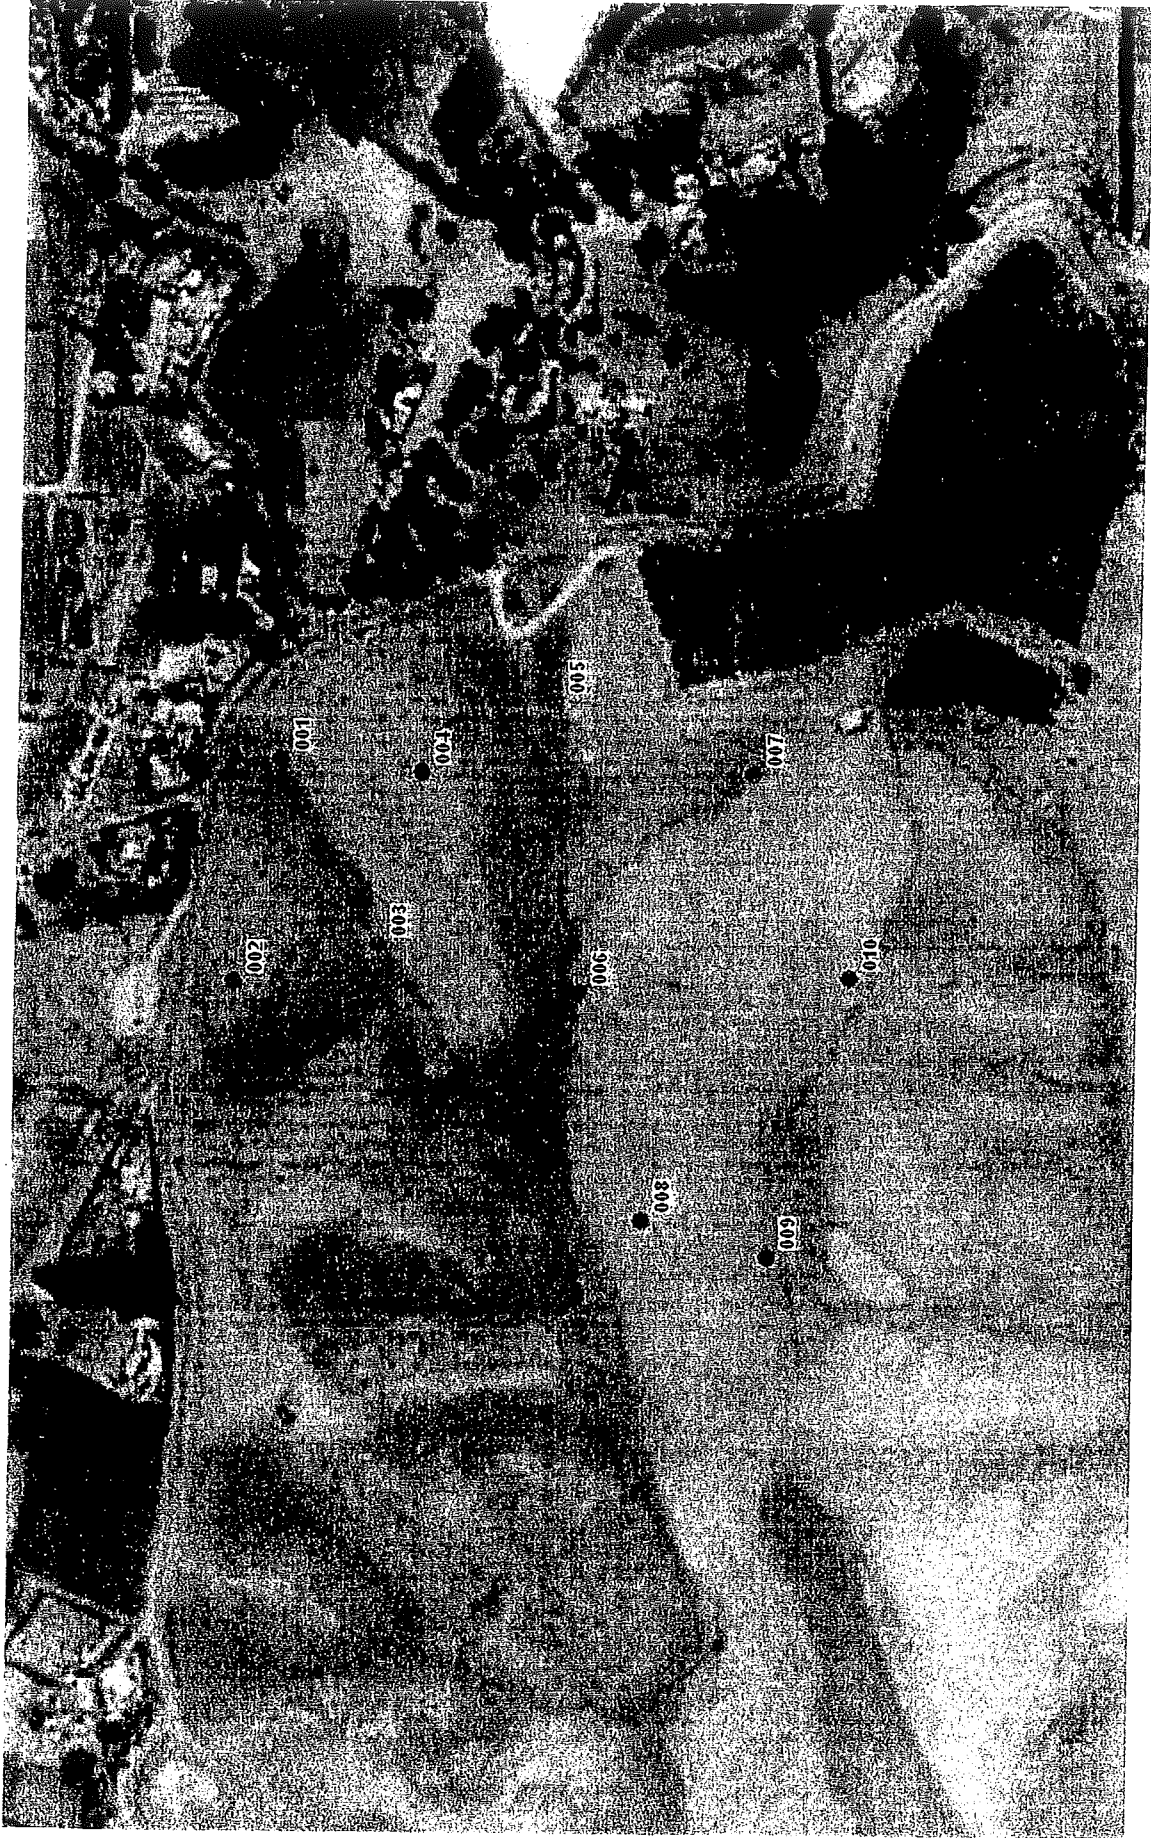
Figure2: Test Pit Location

Field investigations have consisted of reconnaissance engineering geological mapping of available rock outcrops, interpretation of vertical aerial photographs and a series of 10 digger pits spread over the site. Field locations were recorded using a hand held GPS with an accuracy of $\pm 5\text{m}$ on the day and are shown on Figure 2. The digger pit logs are appended to this report.

The two test pits excavated on the floor of the valley (TP 5 & 6) both encountered up to 5 metres of thinly horizontally interbedded, very moist, very dense pumiceous sand and silt. These deposits are interpreted as being recent lake deposits. Up to 4 metres of fill are to be placed in this area and any settlement associated with the fill placement is expected to occur within the period of the earthworks. If soft areas are encountered during the sub excavation prior to fill placement we recommend that these be removed and replaced with fill designed to meet a specified engineering criteria.

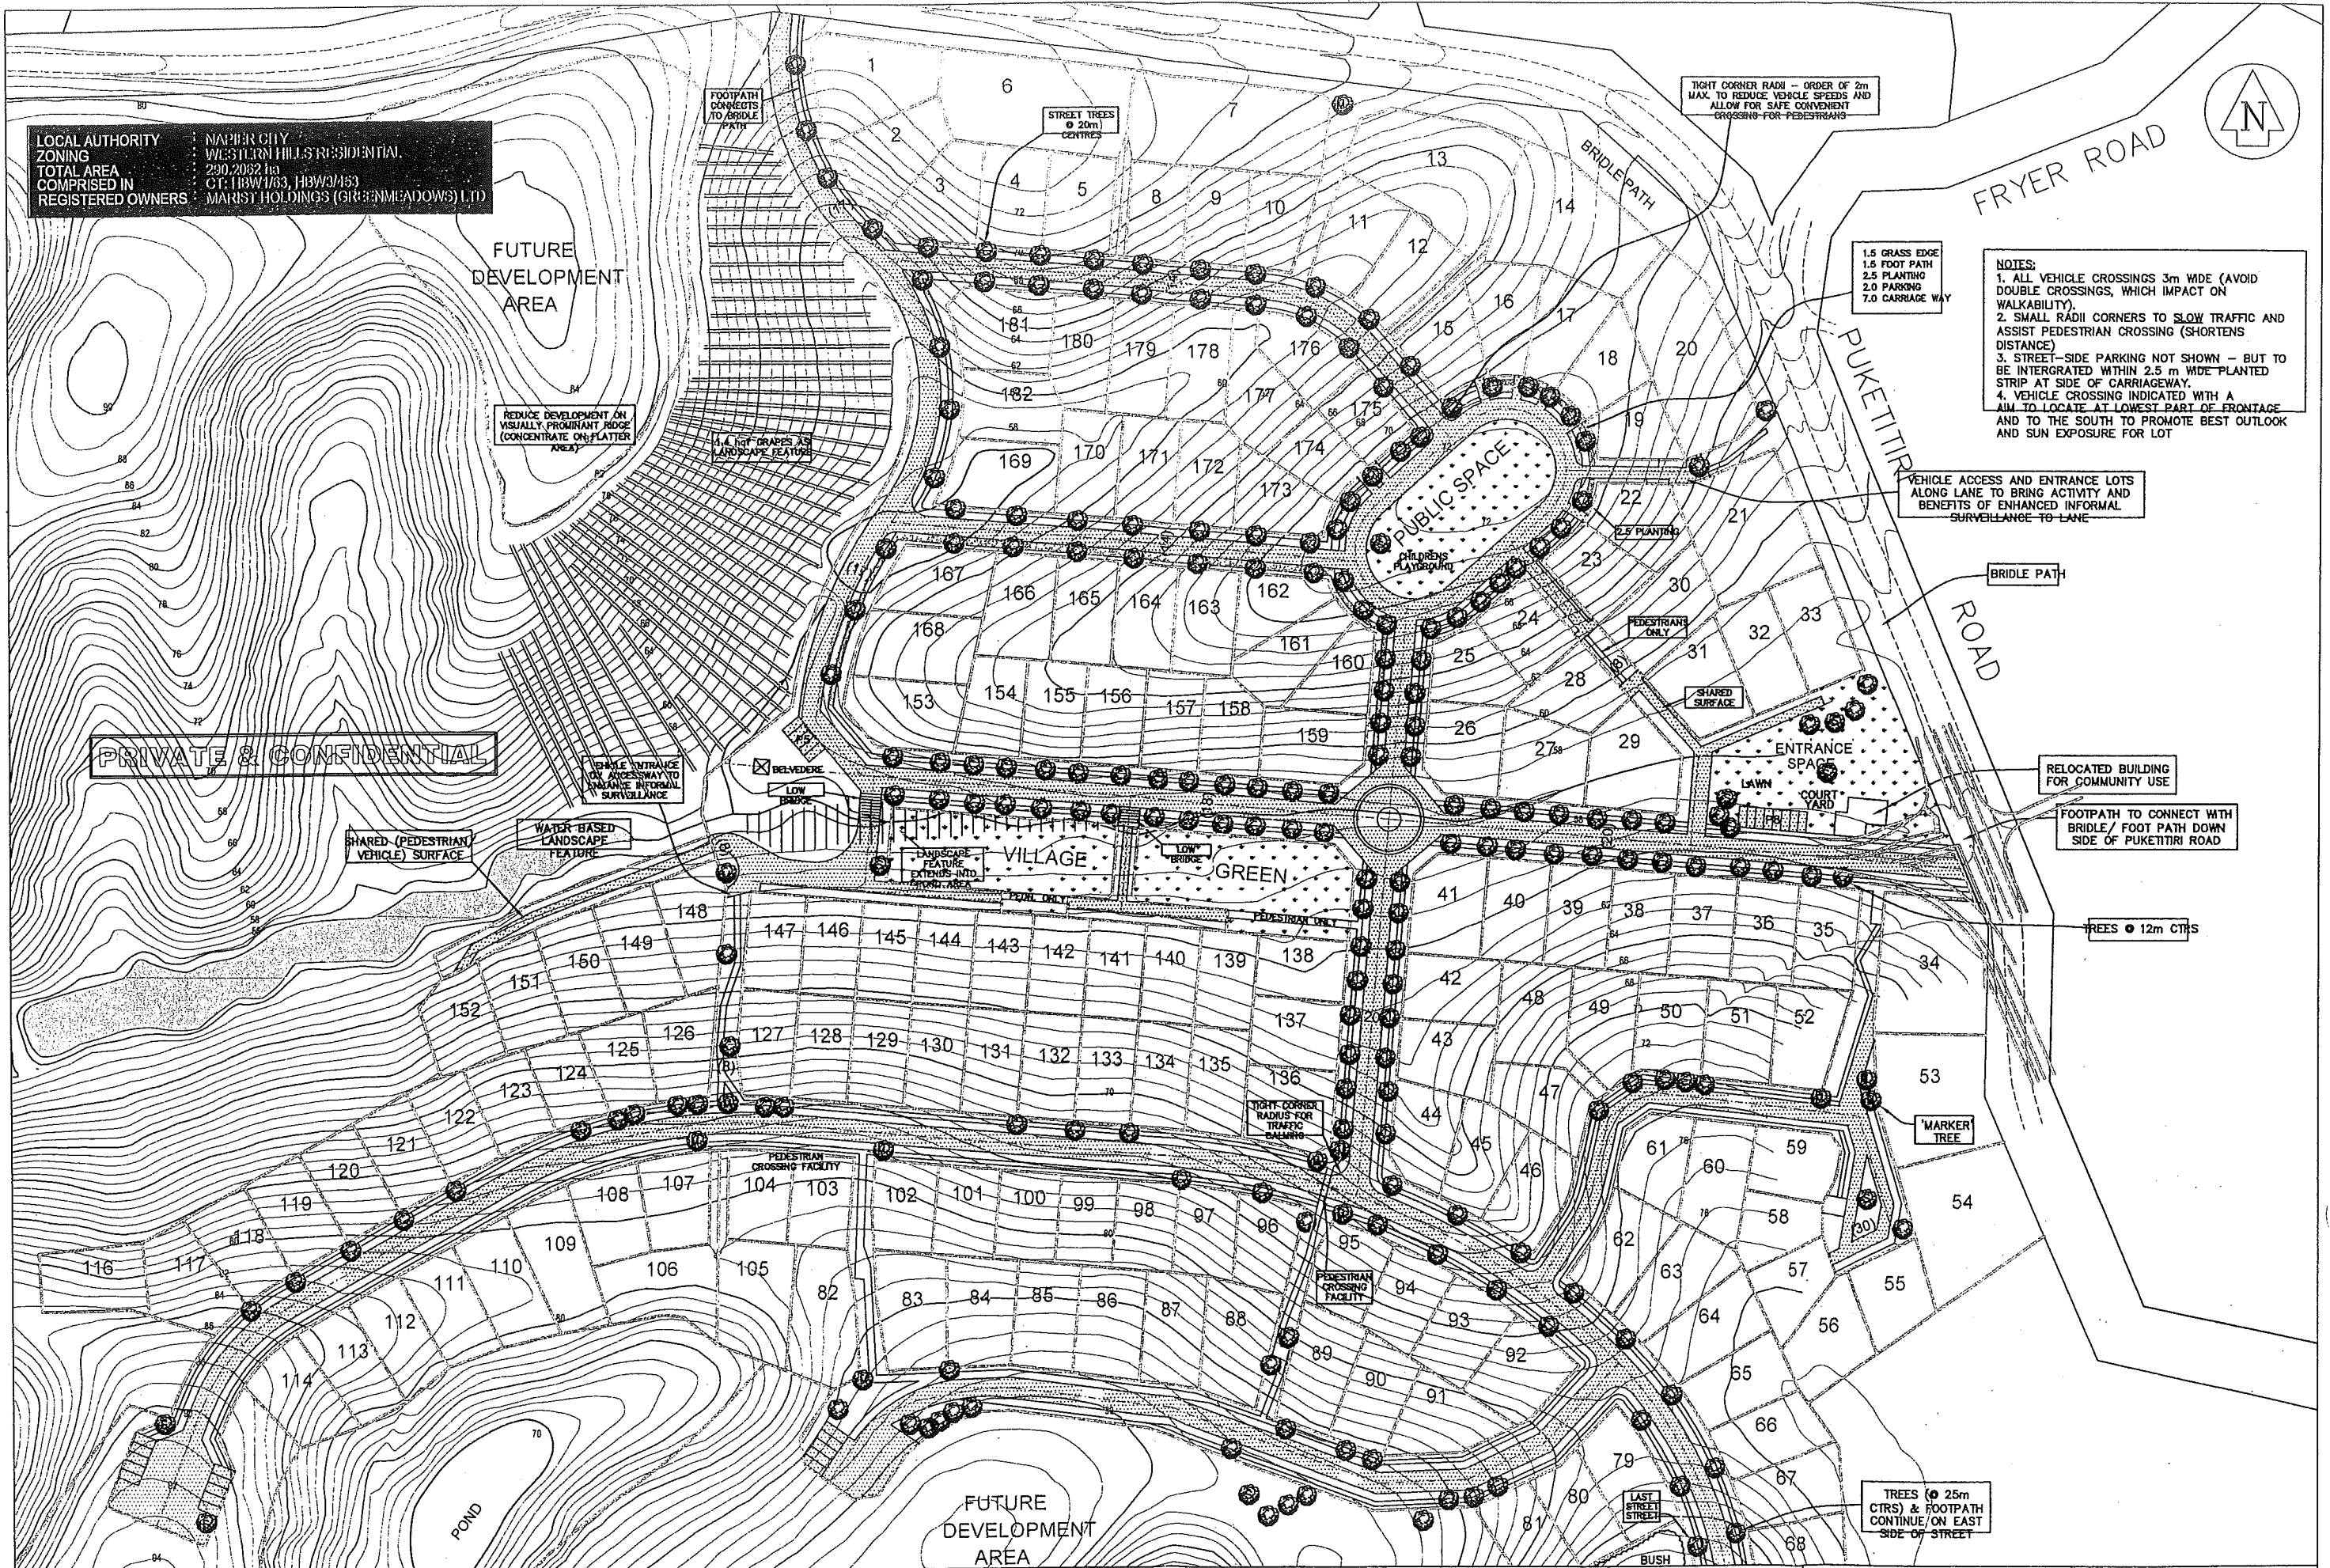
TITLE: SUBDIVISION CONSENT PLAN			
DRAWN: PDT	CHECKED:	SHEET 1 SERIES OF 2	
SCALE: 1:1000 @A1	DATE: NOV 2003	DRAWING NO. 183636/7

The Western Hills Residential Development will involve subdivision of northeastern corner of the 295 hectare Lot 1 DP 27138 to create approximately 200 lots. Bulk earthworks with cuts of up to 5 metres from the crest of the ridges and fills of a similar depth on the valley floor are planned to produce a subdued landscape suitable for medium to high-density residential development. The proposed layout is shown on Design Works Drawing Number 183636/7.

Preparations for the proposed subdivision layout will involve earthworks, both cut and fill, as shown on Figure 3. This will reduce gradients and improved views towards the north. The subdivision layout is shown on

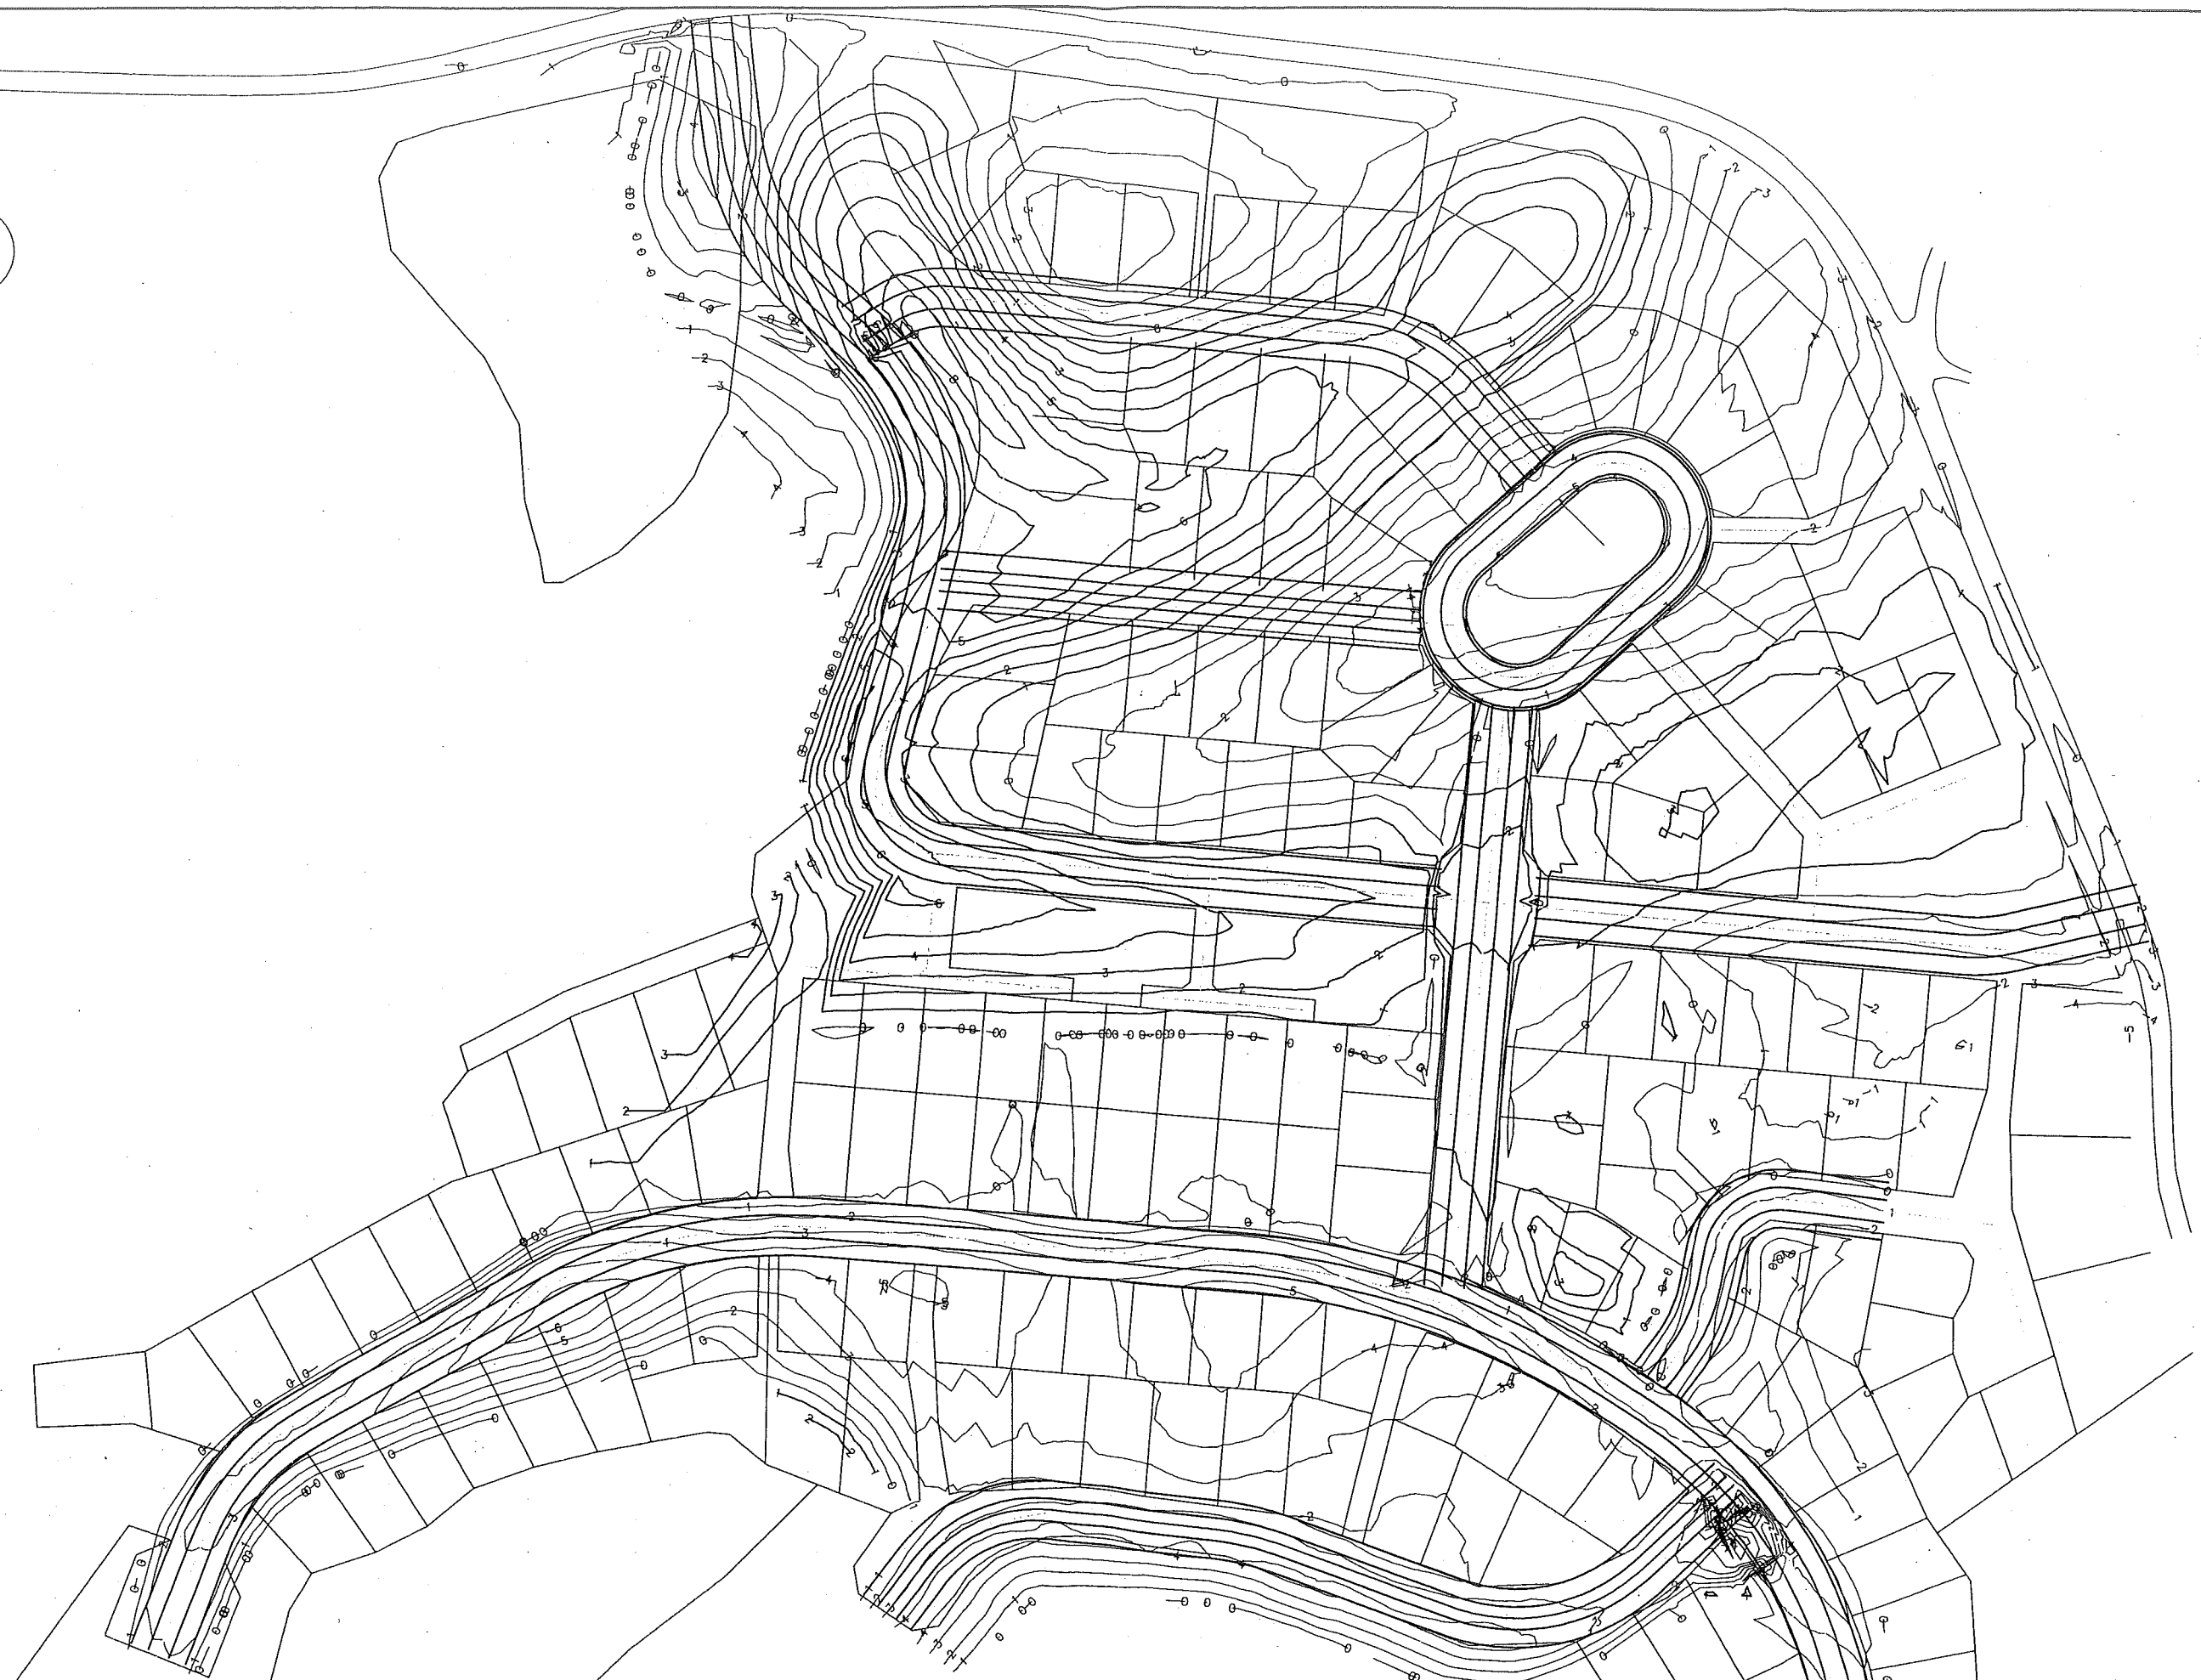
FIGURE 3

Design Works Drawing Number 183636/7. The cut areas are mainly along proposed road alignments as sidling cuts and from some of the ridge crests with the fill being placed in the floor of the main valley and in a south facing side gully as shown on the attached Design Works drawing. Under-drainage may be required to be installed in the floor of the valleys prior to fill placement as very moist soil was encountered in Test Pit 5.
