Onekawa Aquatic Centre -
Geotechnical Assessment

Prepared for
Napier City Council
Prepared by
Tonkin & Taylor Ltd
Date
July 2021
Job Number
1009171.v3

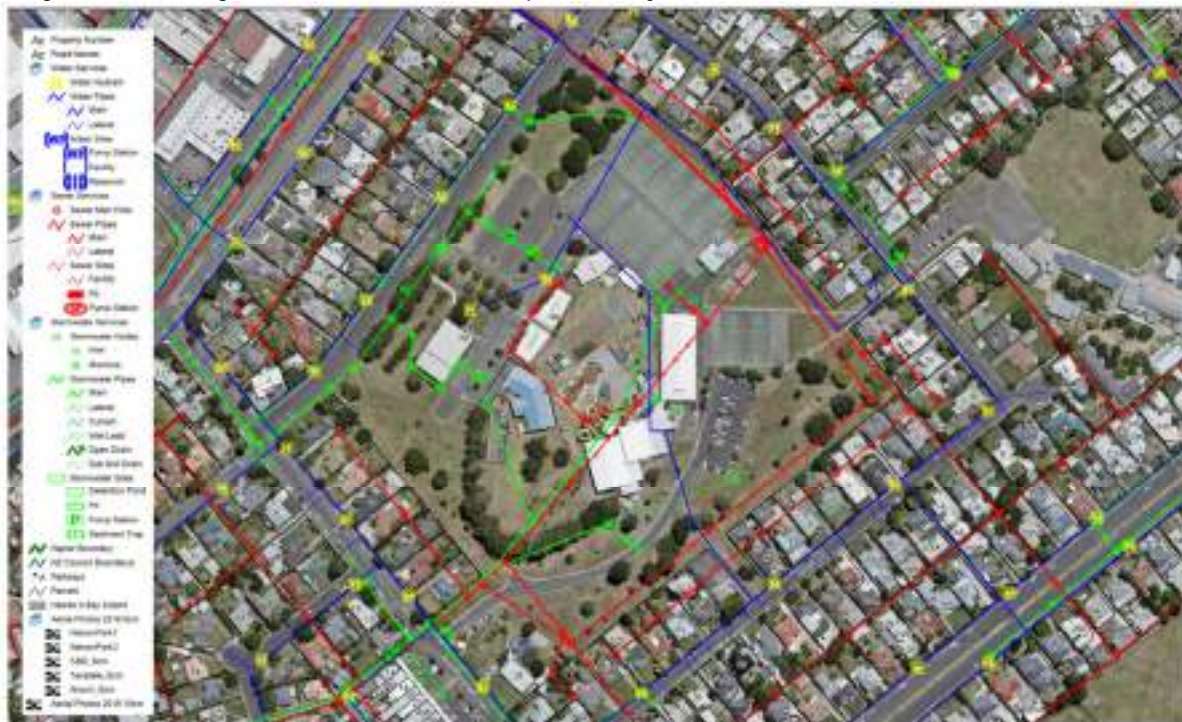
Figure 6.1: Napier City Council Intramaps Service Map.

We recommend that a full infrastructure assessment and topographical survey is carried out prior to design commencing to confirm invert levels, particularly for the trunk sewer line.

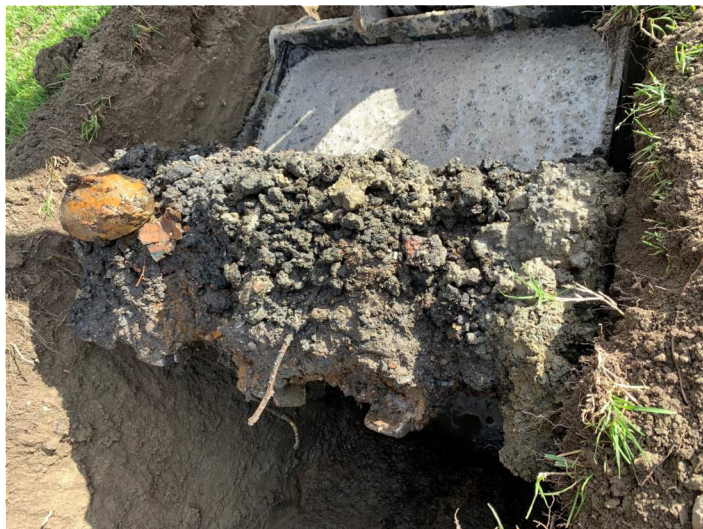
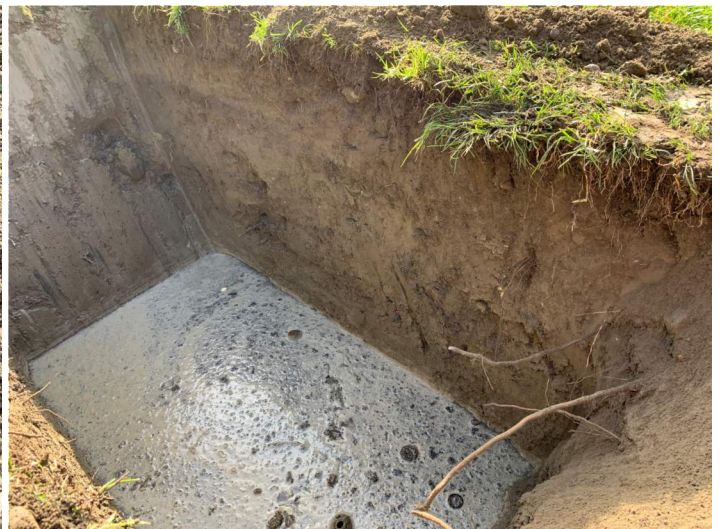
COMMENTS: Groundwater rapidly ran into the hole at 1.2 m. Some gas bubbles coming through the groundwater. Smells like chlorine - suspected chlorine leak from the pools nearby. Significant portions of fill in this test pit.

Test pits 16 and 17 contained significant amounts of brick, glass, ceramics, large, rusted metal sheeting, and ash. They also encountered a significant presence of uncontrolled groundwater inflow. In test pit 17, gas bubbles were observed bubbling to the surface of the ponded groundwater. It is also worth noting, when drilling in the outside pool area (where the outdoor swimming and diving pool used to be located), the drilling rig was unable to penetrate deeper than 3 m depth and was coring into hard concrete. We believe this is at about the right depth to be the remnants of the old swimming/diving pool.

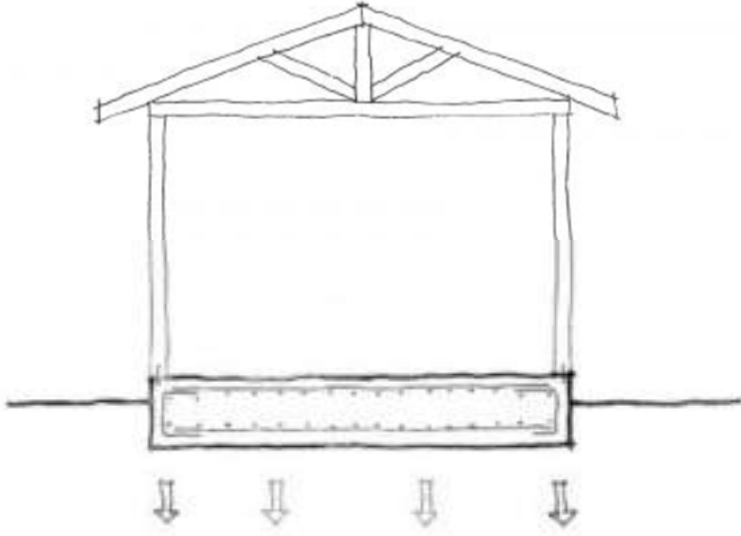
<p data-bbox="320 1444 1160 1503">Step 2: Construct a shallow foundation (i.e., rigid concrete mat or similar overlying shallow gravel raft) on completion of preloading.</p>	<p data-bbox="1196 254 1377 315">Surcharge ~ 2m above ground</p> <p data-bbox="1196 352 1368 548">Shallow foundations constructed following preloading and monitoring.</p>	<ul style="list-style-type: none"> - Proven technique locally with relatively cheap sources of aggregate/fill. - Relatively low cost. - Does not require a specialised contractor. - QA is relatively simple with local surveyor and monitoring. - Material could potentially be reused elsewhere on site following preloading (i.e. hardfill imported then used as carpark subbase). 	<ul style="list-style-type: none"> - Would still require removal of shallow uncontrolled fill. - Programme delays relating to preloading (approx. 1–2-year duration). This can possibly be accelerated with wick drains but would be an additional cost. - Surcharge over existing services may require the diversion of existing SW/SS/Water lines. - Potentially disruptive to site operations if preload in place for significant duration. - Preload takes longer than anticipated, leads to programme delays. 	<p data-bbox="2421 254 2772 415">Pool complex: <u>Unlikely</u> - due to large amount of underground services, large fill volume required and disruption to the site</p> <p data-bbox="2421 453 2772 653">Gym extension: <u>Yes</u> – Expected to be suitable for the gym complex. Shallow foundation system overlying an engineered gravel raft, following preloading.</p>

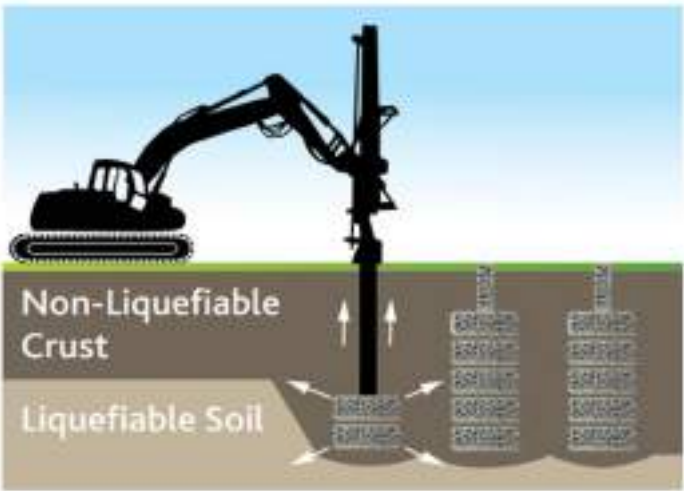
<p>Geopier Rammed Aggregate Pier™ System (RAP)</p>	~ 6-8m	<ul style="list-style-type: none"> - Relatively lower cost than piling options. - Relatively quick installation. - Option to densify liquefiable layers as well as reduce settlements through stiffening. - Generally low noise and vibrations. - No spoil (i.e. removal of contaminated soils). 	<ul style="list-style-type: none"> - Modest plant required. - Specialised contractor required. - Proprietary product (only one company have licence in NZ). - Specialist QA required. - Construction through soft silt will likely require grout additive to increase column stiffness. 	<p>Pool complex: <u>Yes</u> - appropriate for pool building.</p> <p>Gym extension: <u>Yes</u> - but would need to be installed to greater depths.</p>
