+  
Onekawa Aquatic Centre -  
Contaminated Land  
Assessment

Prepared for  
Napier City Council  
Prepared by  
Tonkin & Taylor Ltd  
Date  
March 2021  
Job Number  
1009171.v1

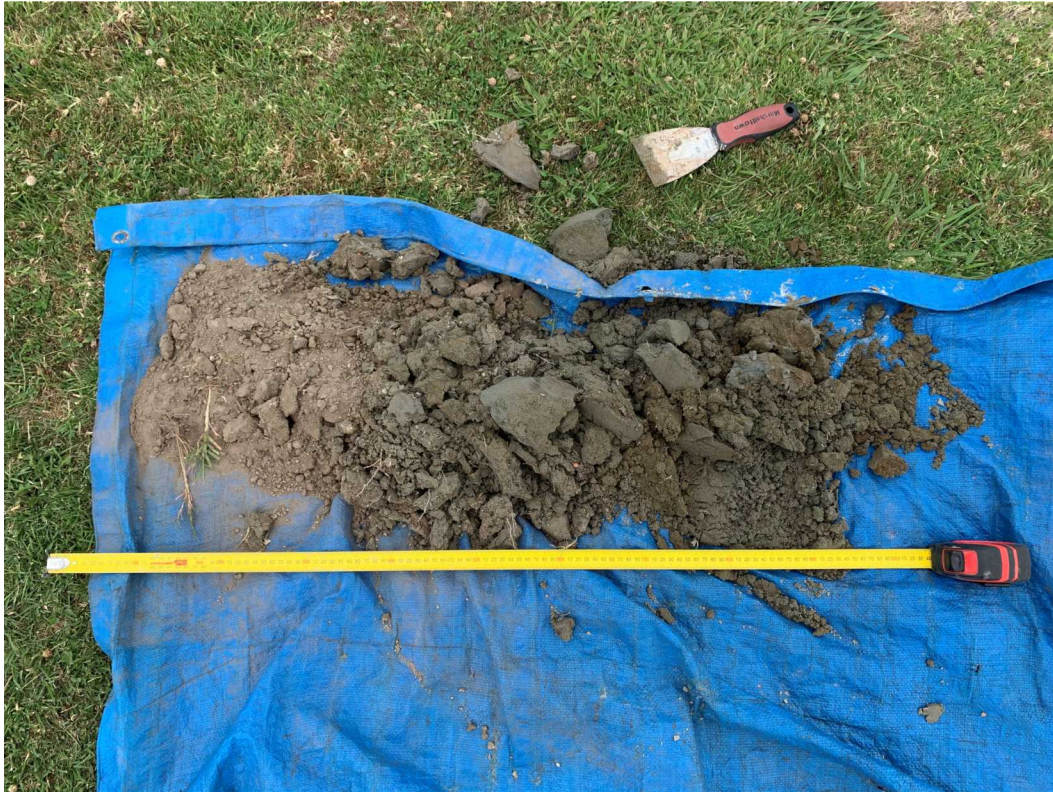
0.00-1.15m

GEOLOGICAL										ENGINEERING DESCRIPTION															
GEOLOGICAL UNIT, GENERIC NAME, ORIGIN, MATERIAL COMPOSITION	WATER	CORE RECOVERY (%)	METHOD	SCALA PENETROMETER (Blows/100mm)										TESTS	SAMPLES	RL (m)	DEPTH (m)	GRAPHIC LOG	MOISTURE CONDITION	WEATHERING	STRENGTH DENSITY CLASSIFICATION	SHEAR STRENGTH (kPa)	Description and Additional Observations		
				0	1	2	3	4	5	6	7	8	9												
Fill															A+M @ 0.20m						D	D			Silty, fine SAND, minor gravel; light brown. Tightly packed, dry, well graded. Gravel, fine.
Holocene Estuarine		100	HA												A+M @ 0.50m		0.5			M	L			Fine SAND; grey, mottled brown. Loosely packed, moist, uniformly graded.	
																A+M @ 1.00m		1.0			S			SILT; grey. Soft, moist, low plasticity.	
																								1.15m: END OF INVESTIGATION

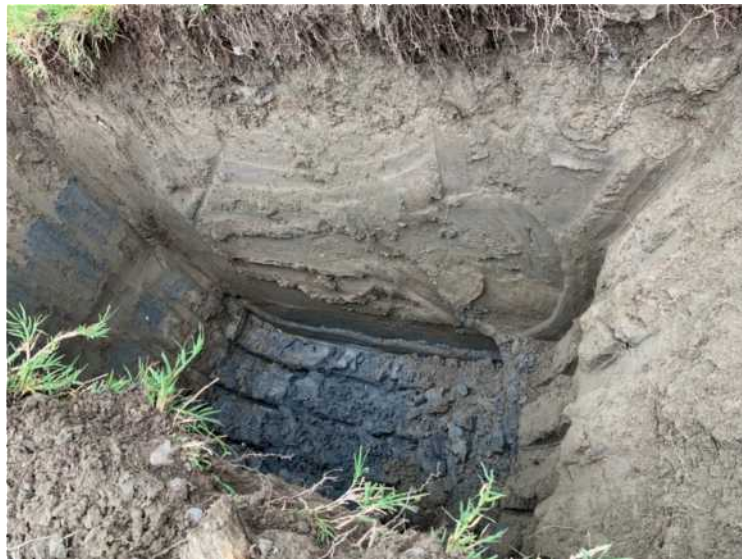
COMMENTS: Groundwater not encountered in this hole.

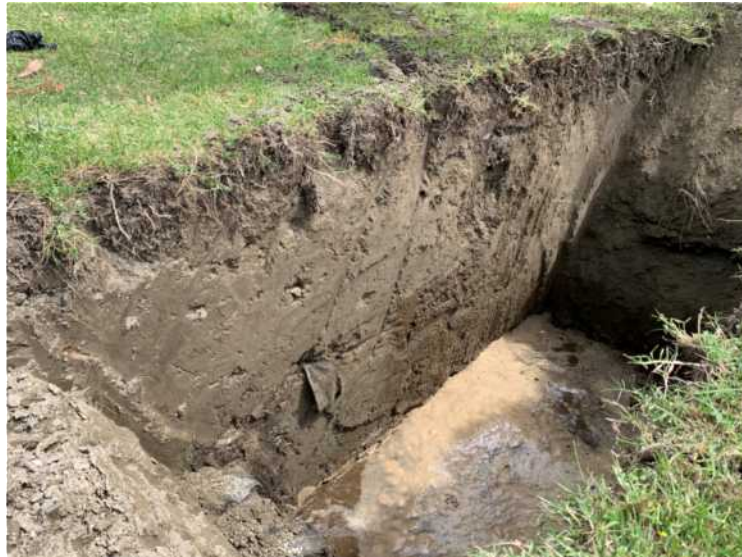
1.5m: Test pit terminated due to significant groundwater ingress.					1.5m: Glass jar and asbestos sample		Fill

COMMENTS: Groundwater rapidly ran into the hole at 1.3 m. Lots of gas bubbles coming through the groundwater. Backfilled test pit and covered with a truck load of top soil. Significant portions of fill in this test pit.

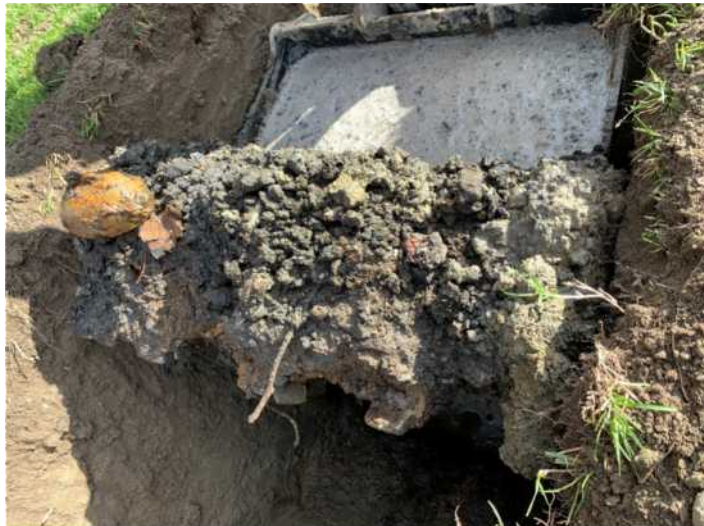
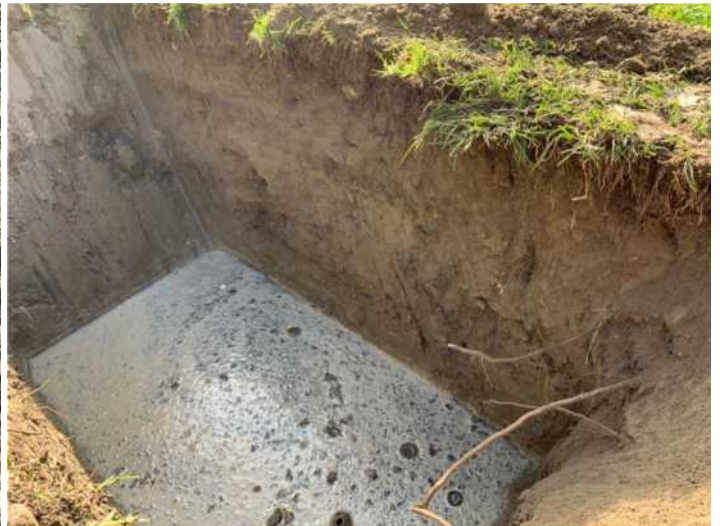
COMMENTS: Groundwater rapidly ran into the hole at 1.2 m. Some gas bubbles coming through the groundwater. Smells like chlorine - suspected chlorine leak from the pools nearby. Significant portions of fill in this test pit.

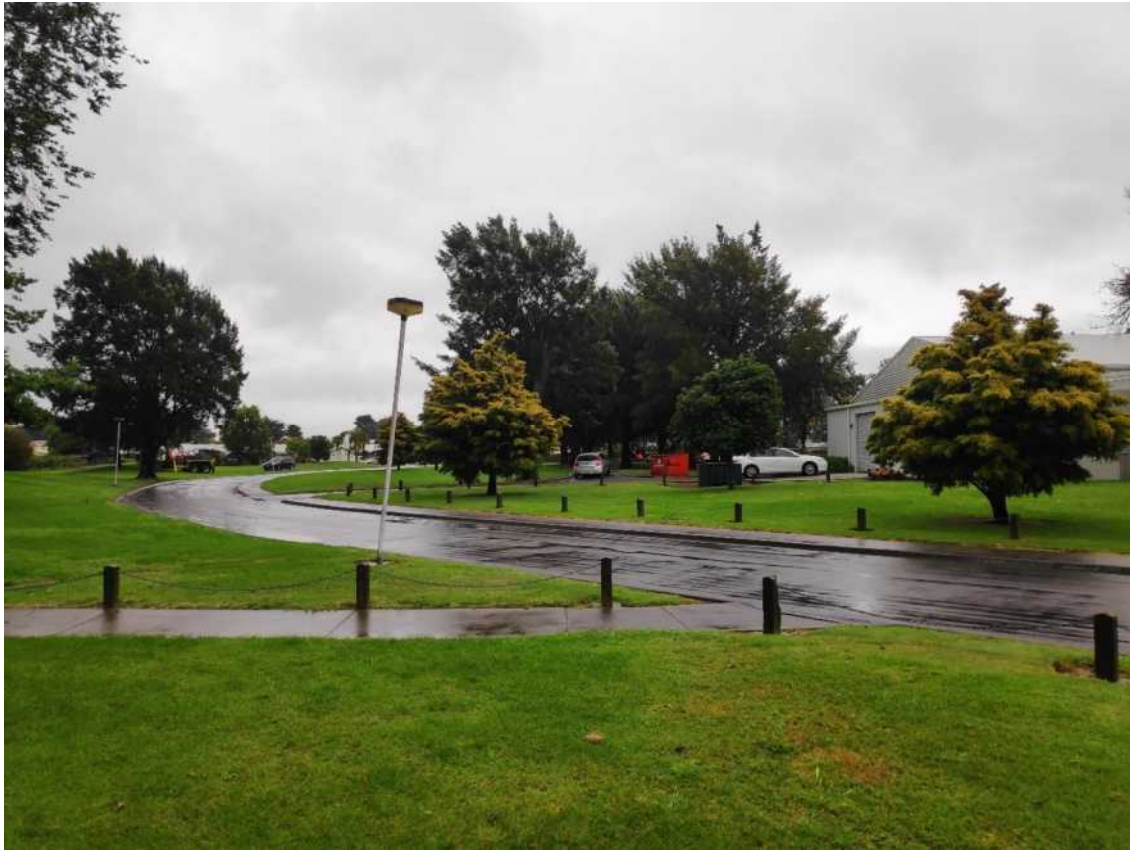
- Approximately half the property is grassed, with the remainder paved with asphalt for carparking and netball courts. Pavements are generally in good condition with a few cracks locally. Grass and other vegetation including bushes and trees on the property appeared to be generally healthy, although small brown patches were noted in some areas (refer to Photograph 1).

*Photograph 1: Photograph showing the general topography of the site.*

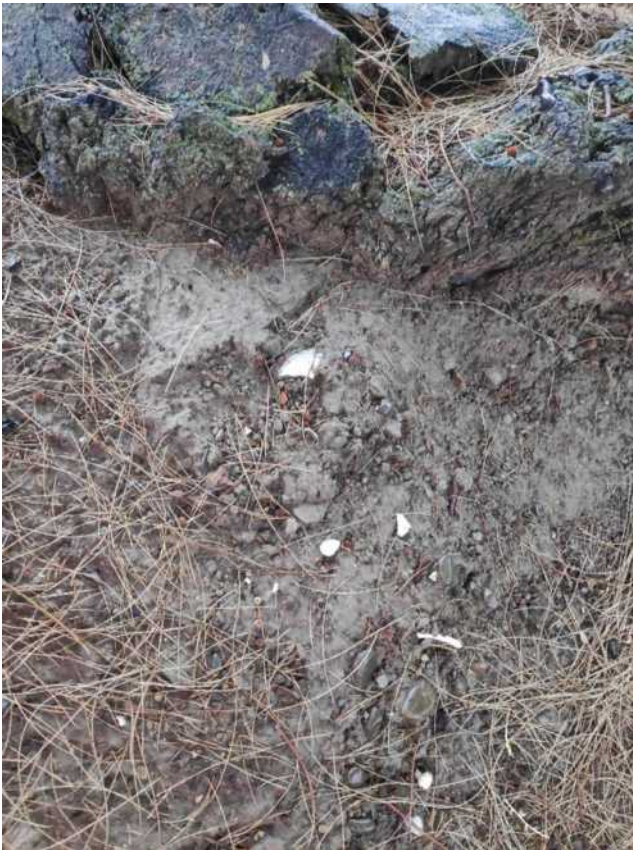
- Fragments of ceramics, concrete, glass, and metal were exposed in surface soil at several locations around the property (refer to Photograph 2).
- There are eight buildings within the property of varying age and construction materials. These include timber, cement block, corrugated and long-run iron/steel and brick. Several buildings also have soffits and/or cladding constructed out of cement board that may be an asbestos containing material (ACM). These cladding and soffit materials are in a moderately good condition with some areas of flaking paint and cracking noted (refer to Photographs 3-6).

*Photograph 2: Example of ceramics, concrete, glass and metal observed in surface soil at the property.*

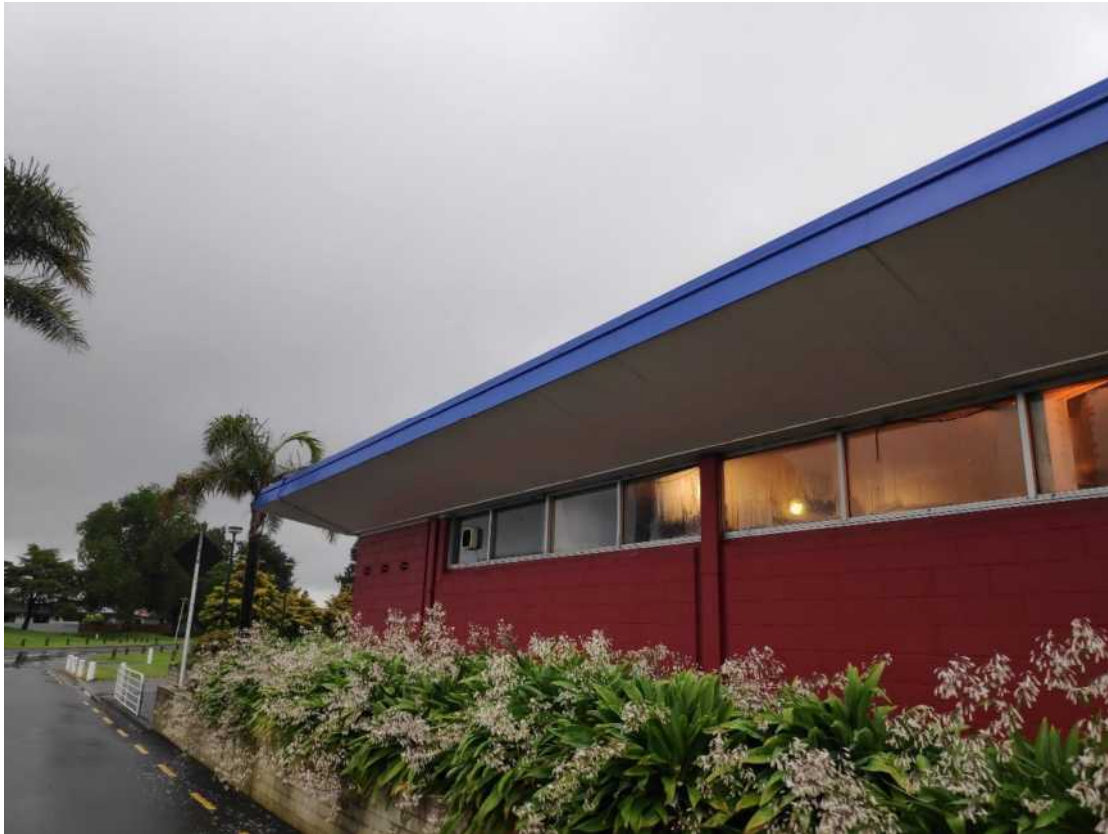
*Photograph 3: Photograph showing the construction materials of onsite buildings.*

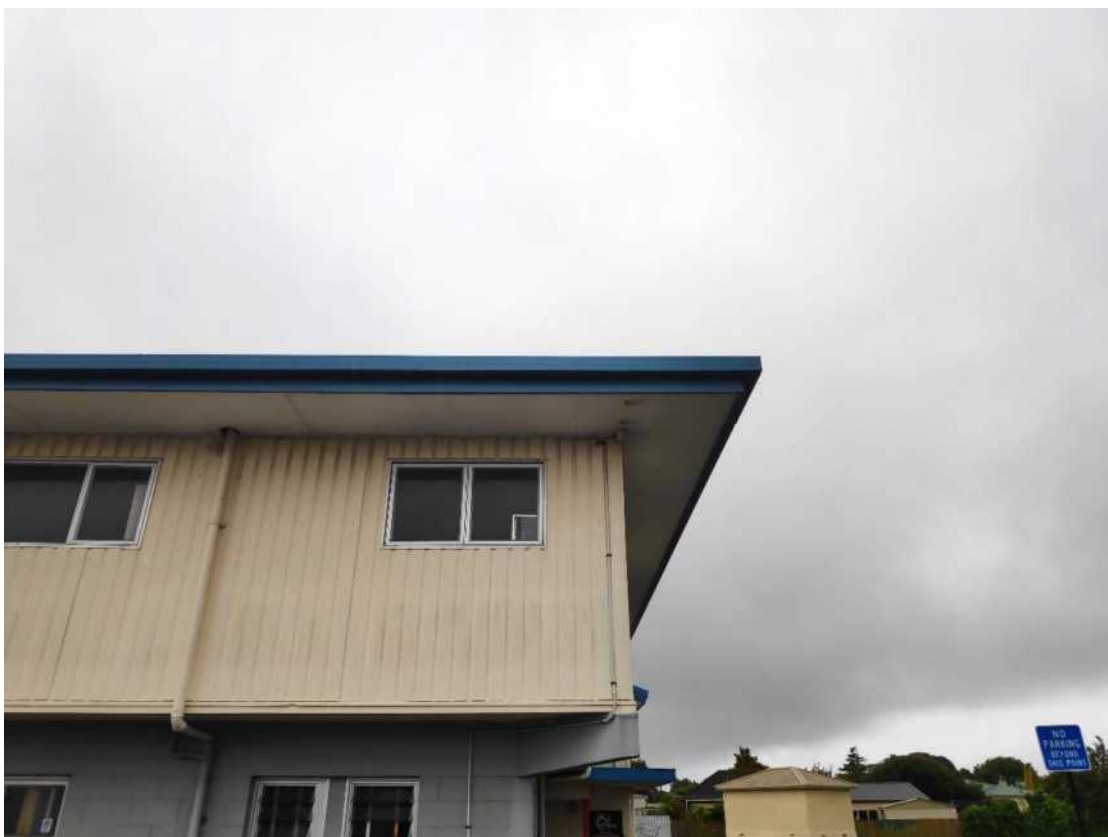
*Photograph 4: Photograph showing the construction materials of onsite buildings.*

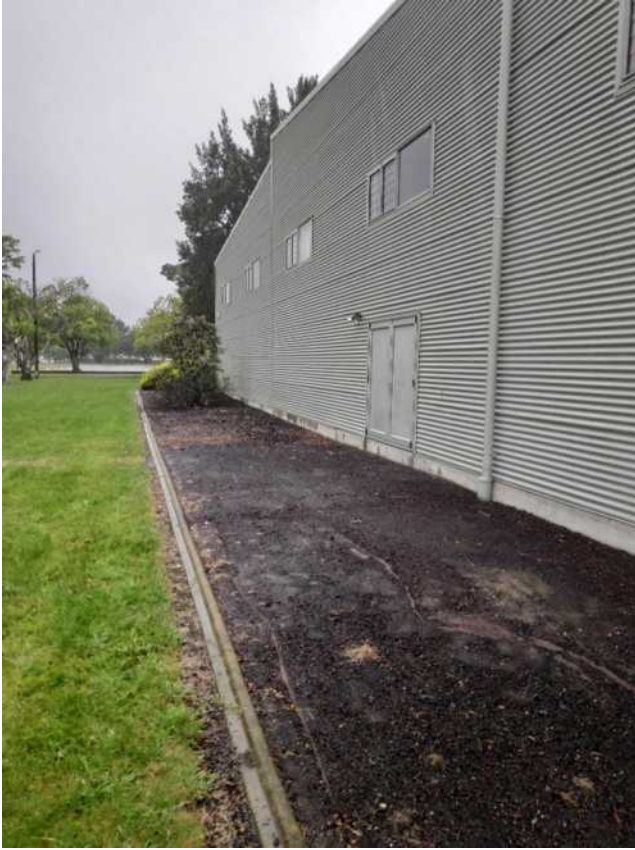
*Photograph 5: Photograph showing the construction materials of onsite buildings.*

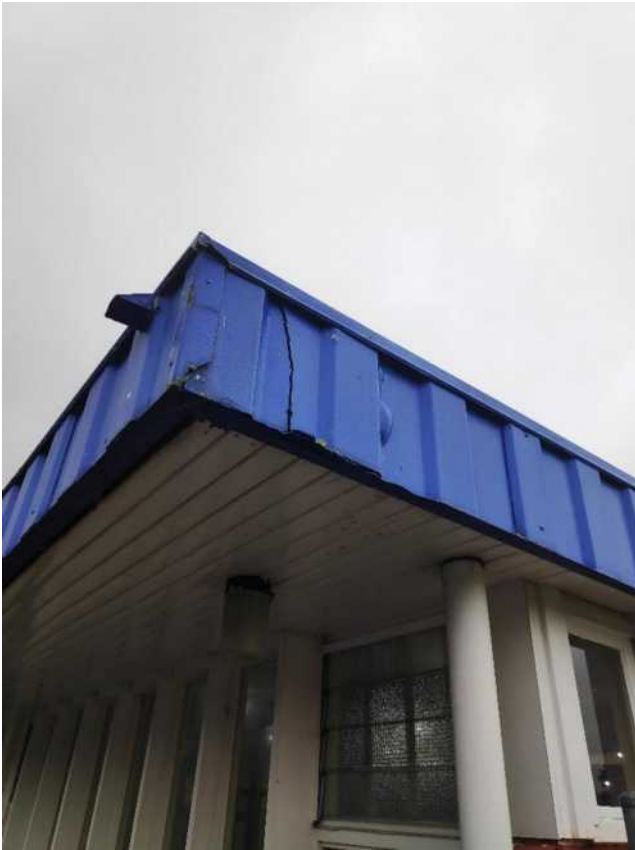
*Photograph 6: Photograph showing the construction materials of onsite buildings.*

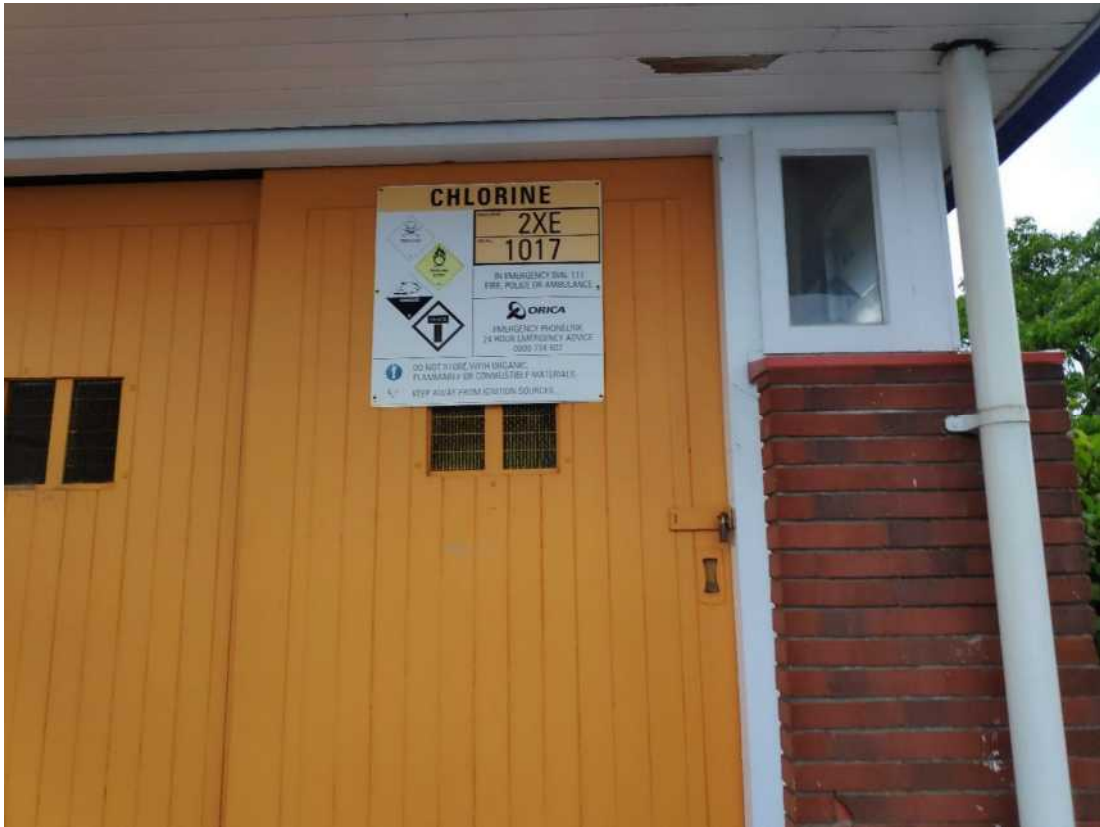
- A store containing chlorine is present within proposed redevelopment area Option 3; no indications of leakages were observed from the exterior (refer to Photograph 7).

Photograph 7: Hazardous storage shed.

In addition, given the presence of hardstand by the existing transformers, no sample locations were targeted to these locations nor the hazardous chemical shed. Additional investigation will be required to be undertaken into these activities at a later date.

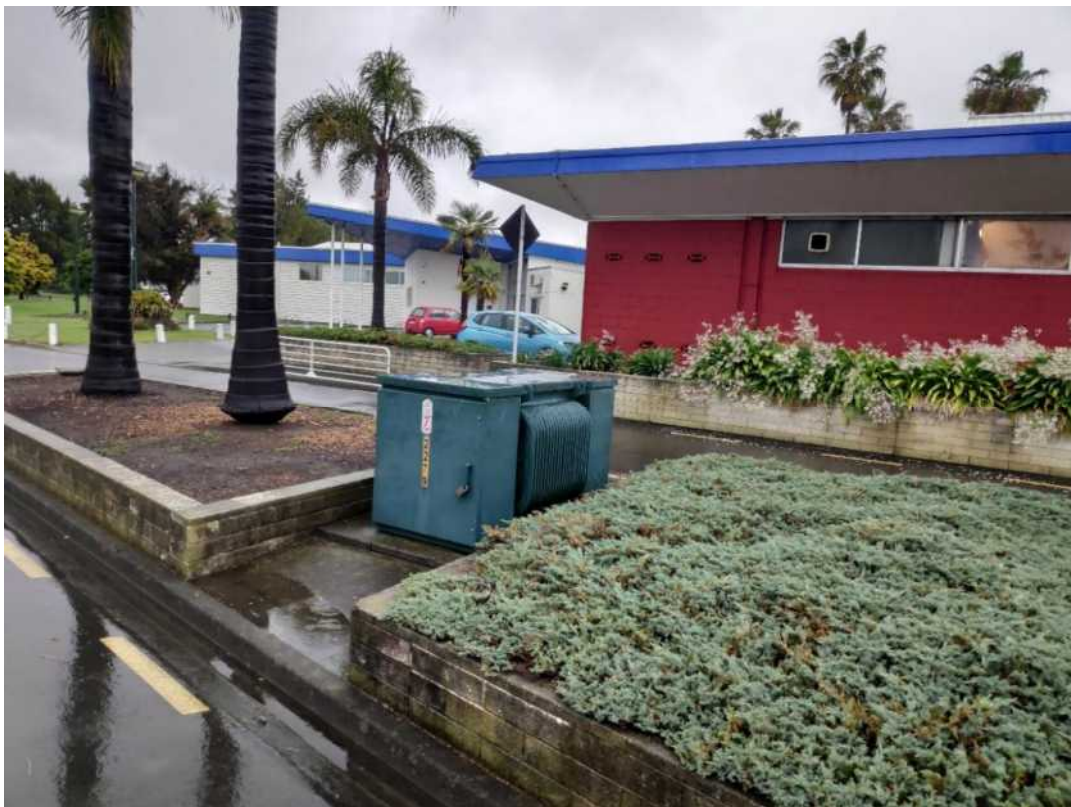
- Three small electrical transformers are present on the property, one adjacent to proposed development are Option 5. The transformers are in good condition with no indications of leakages observed (refer to Photograph 8).

Photograph 8: An example of the electrical transformers observed onsite.

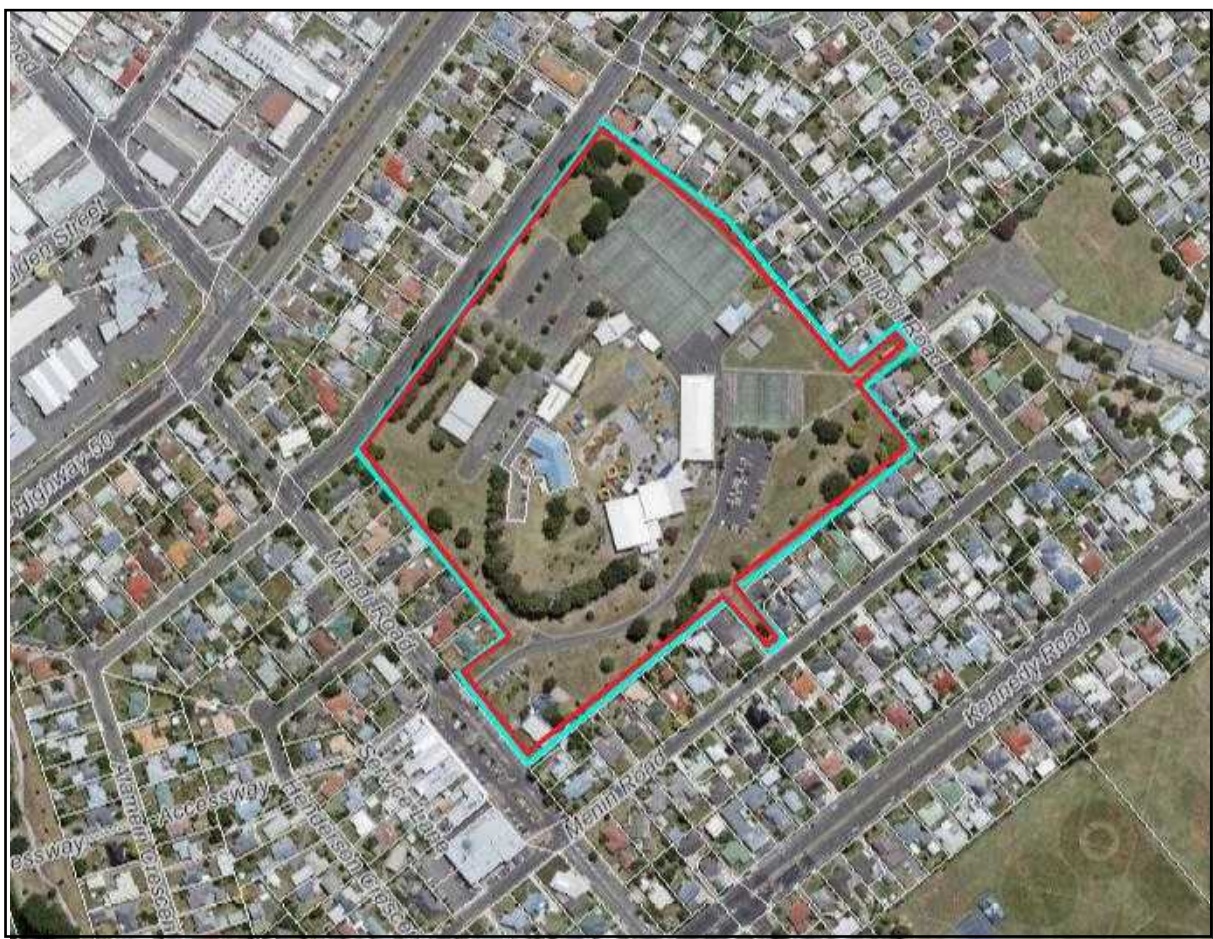
Area of enquiry
 	Listed sites

*The above map outlines the specific parcel(s) or area(s) where contaminated land information has been requested*

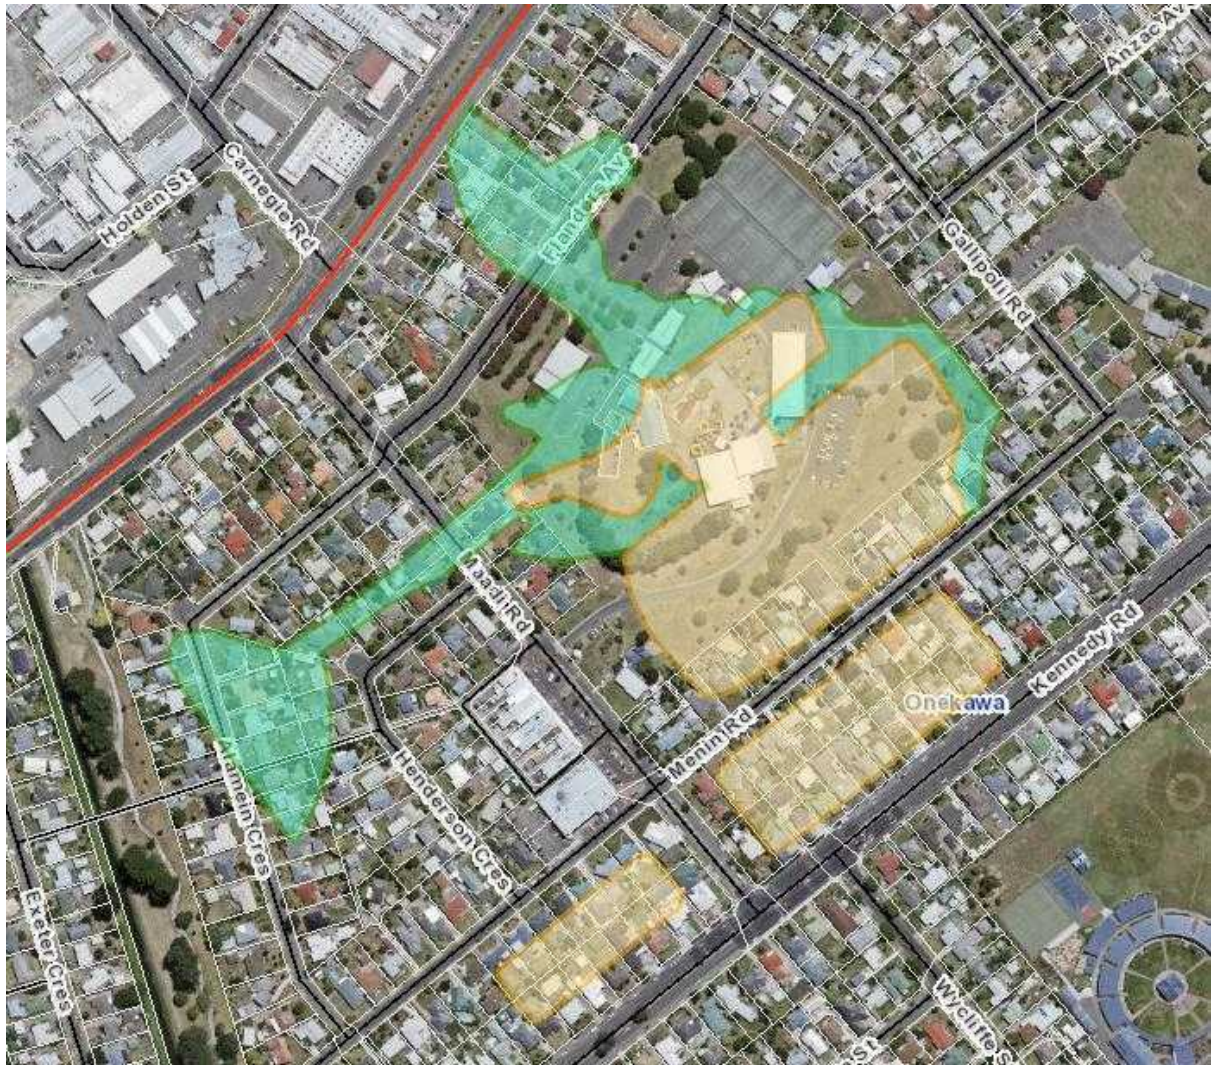
Photo 1: Onekawa likely landfill extent area

*Yellow: reasonable confidence that landfilling activities have occurred.*
