RANGATIRA REEF BENTHIC SURVEY AND ASSESSMENT OF ENVIRONMENTAL EFFECTS

OF THE PROPOSED
WHAKARIRE AVE, BREAKWATER

Prepared for
NAPIER CITY COUNCIL

October 2008

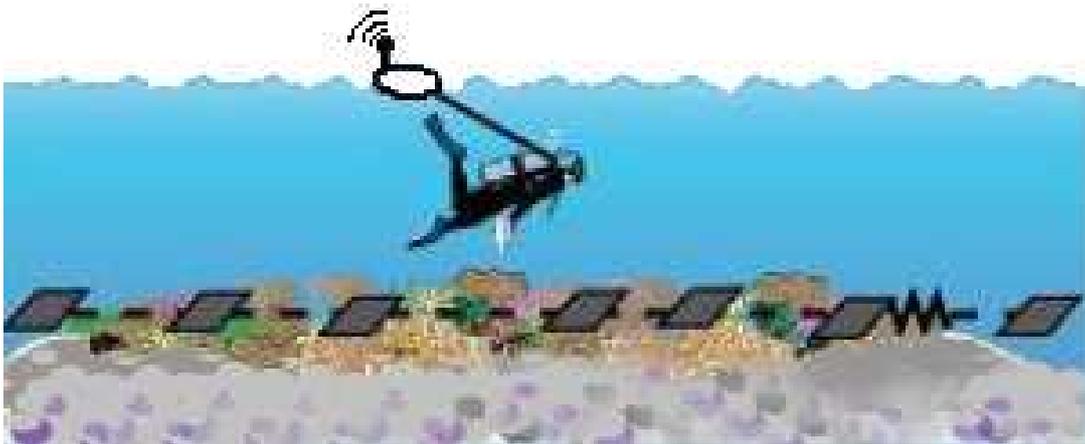
FIGURE 2: GRAPHIC OF DIVER WITH RAFT AND GPS UNIT ATTACHED AND PHOTO TRANSECT

The benthic environment of Rangatira Reef was surveyed using underwater digital photography with integrated GPS location data (methodology modified from Roelfsema (2007)). This technique involved a SCUBA diver taking underwater still photographs along a transect line (photo transect) as a basis to identify and assess subtidal reef habitat types. Each habitat type represents the biological community or assemblage that is the product of the physical and biological variables influencing the reef. The photos were geo-referenced through post processing of the track recorded by a GPS, with the GPS being towed by the same diver taking the photos (Figure 2).

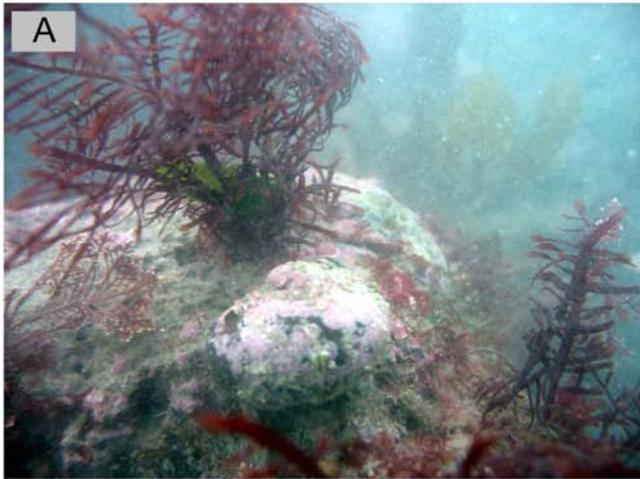
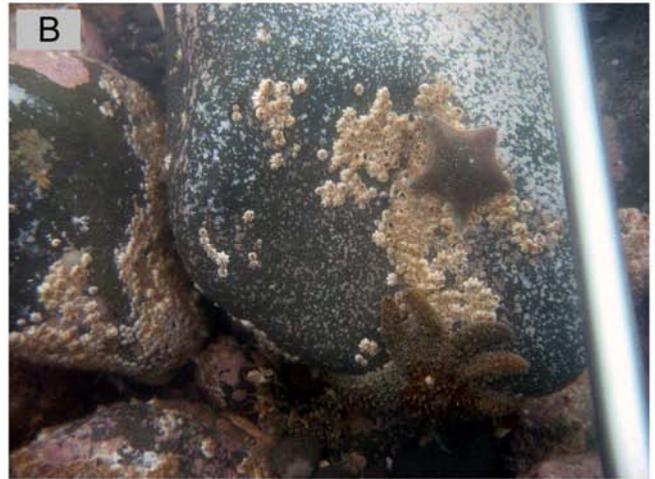
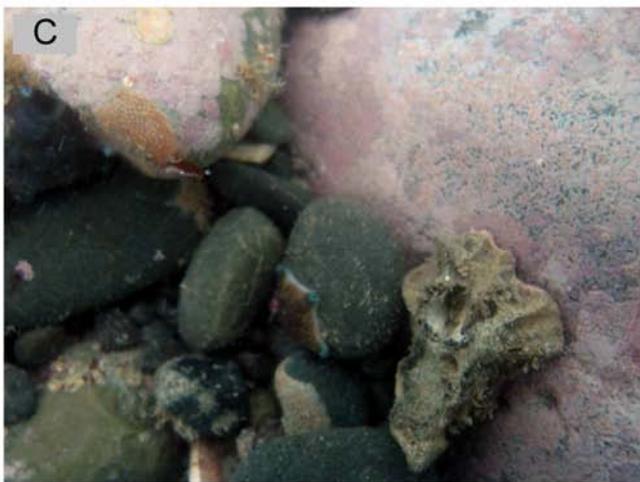
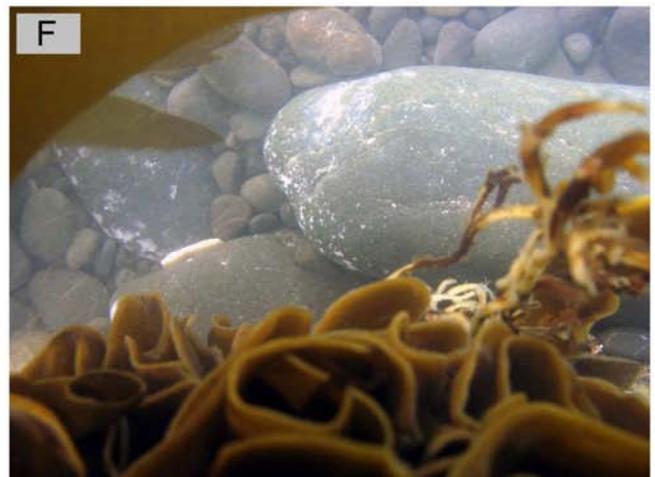
PLATE 1: PHOTOS SHOWING TYPICAL REEF SPECIES ENCOUNTERED WHILE CONDUCTING PHOTO TRANSECTS: A) TURBO SMARAGDUS AND RED SEAWEED *GIGARTINA* SP. – RED FOLIOSE ALGAE HABITAT TYPE, B) *PATIRIELLA REGULARIS* AND JUVENILE *COSCINASTERIAS MURICATA* SEA STARS FEEDING ON *CHAMAESIPHO BRUNNEA* BARNACLES – COBBLE HABITAT TYPE C) *SACCOSTREA GLOMERATA* (RIGHT) AND ORANGE COLOURED BRYOZOAN (LEFT) – ENCRUSTING INVERTEBRATE HABITAT TYPE D) *CYMATIUM SPENGLERI*, LARGE PREDATORY TRITON – SHALLOW *CARPOPHYLLUM* UNDERSTORY, E) *COOKIA SULCATA* – TURFING ALGAE HABITAT TYPE F) SPOROPHYLL OF *UNDARIA PINNATIFIDA* – COBBLE HABITAT TYPE.

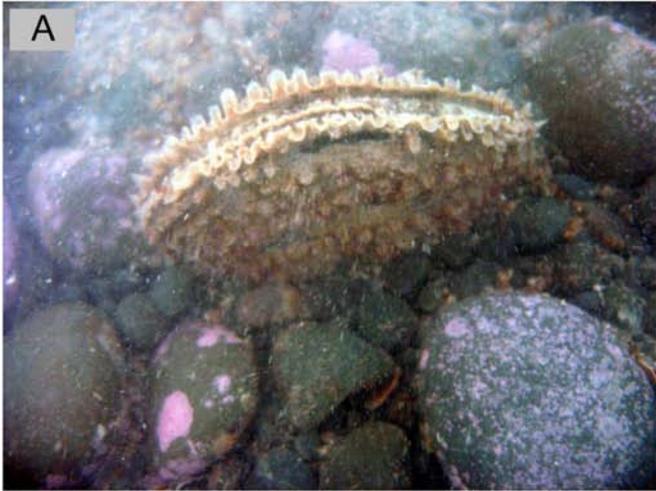
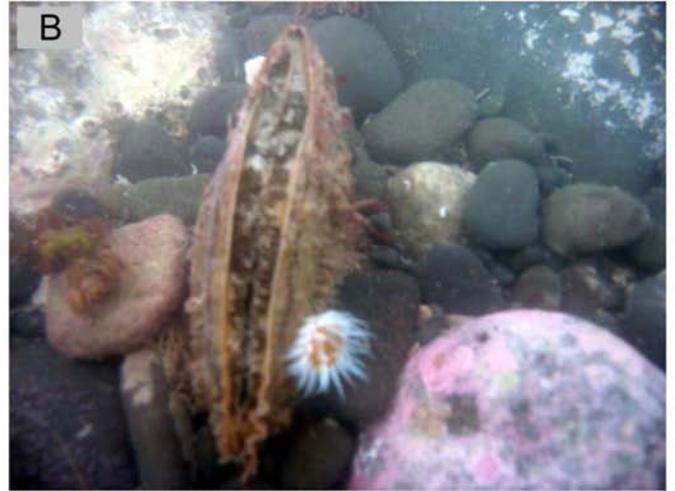
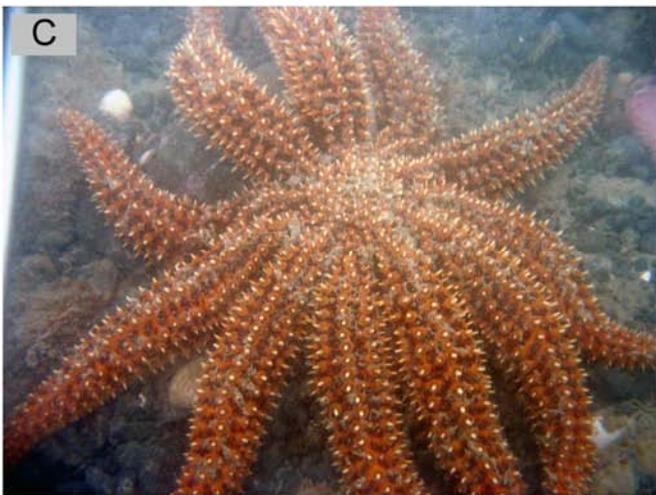
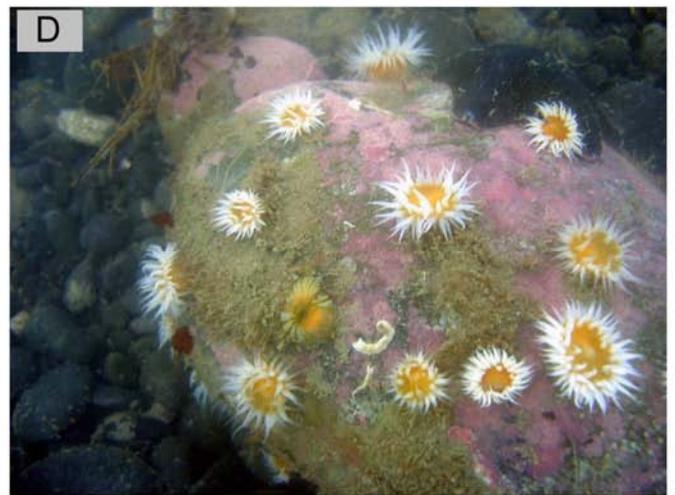
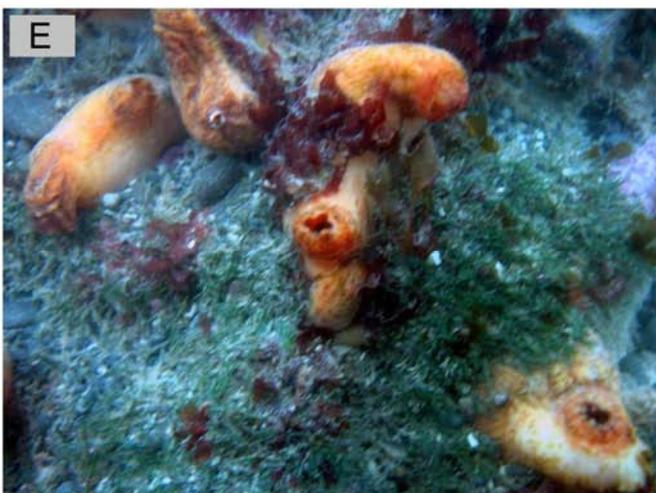
PLATE 2: PHOTOS SHOWING TYPICAL ENCRUSTING INVERTEBRATE HABITAT TYPE: A) *ATRINA ZELANDICA*, HORSE MUSSEL, B) *ATRINA ZELANDICA* AND EPIBIONT *ACTINOTHOE ALBOCINCTA*, C) *COSCINASTERIAS MURICATA*, D) COMMON ANEMONES, *ACTINOTHOE ALBOCINCTA*, E) SOLITARY ASCIDIANS *CNEMIDOCARPA BICORNUTA*, F) STALKED, SOLITARY ASCIDIAN *PYURA PACHYDERMATINA*.

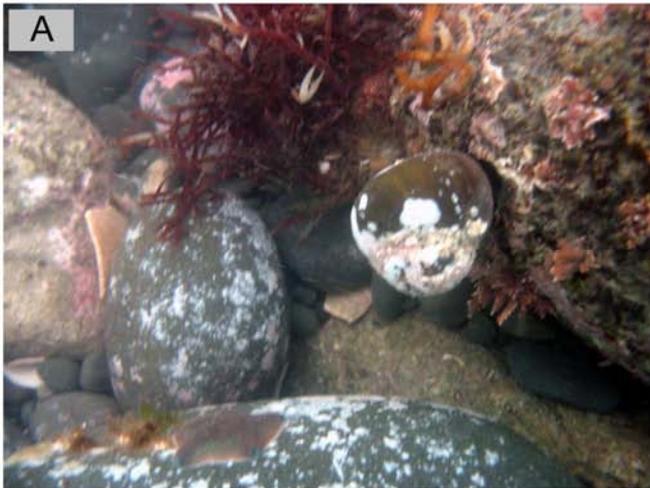
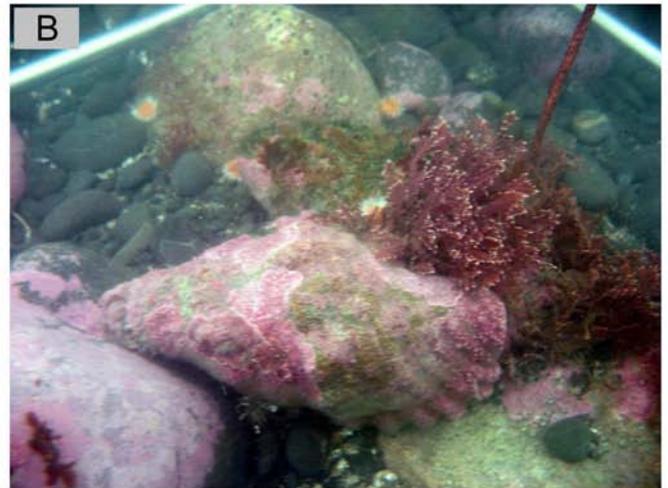
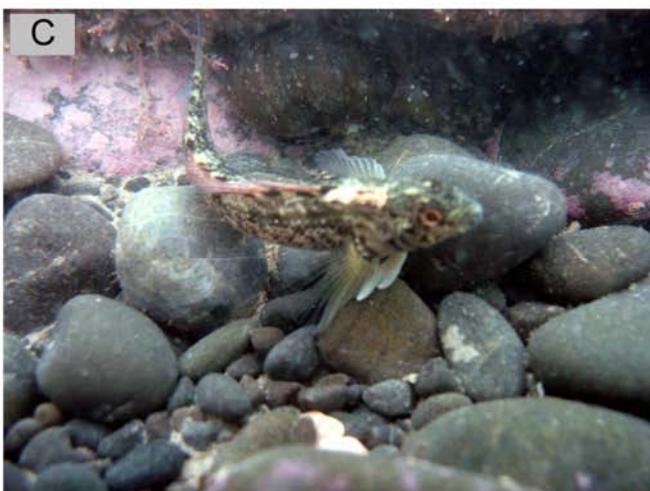
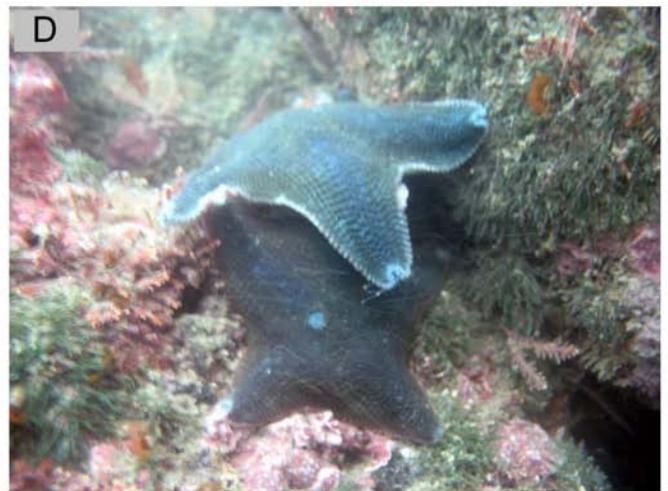
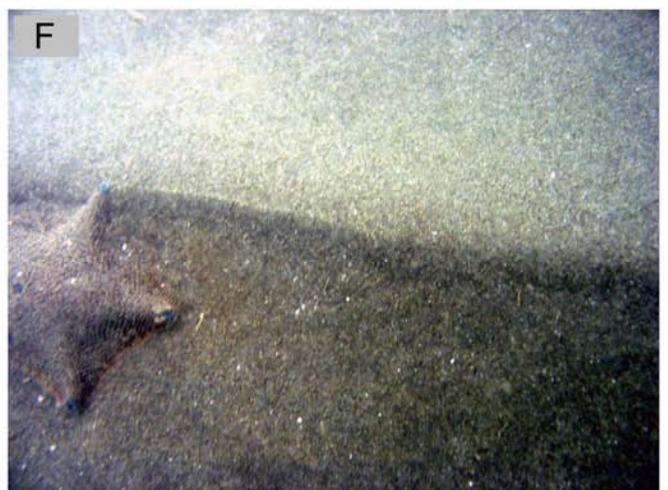
PLATE 3: PHOTOS SHOWING TYPICAL REEF SPECIES ENCOUNTERED WHILE CONDUCTING PHOTO TRANSECTS: A) *TURBO SMARAGDUS* – SHALLOW *CARPOPHYLLUM* HABITAT (UNDERSTORY), B) *CYMATIUM SPENGLERI* BESIDE A CLUMP OF THE UBIQUITOUS ENCRUSTING RED SEAWEED, CORALLINE TURF – TURFING ALGAE HABITAT TYPE, C) *TRIPTERYGION* SP. UNIDENTIFIED TRIPLEFIN SPECIES – TURFING ALGAE HABITAT TYPE D) TWO *PATIRIELLA REGULARIS* – TURFING ALGAE HABITAT TYPE, E) *TURBO SMARAGDUS* AND *ATRINA ZELANDICA* WITH RED ALGAE EPIPHYTIC GROWTH – ENCRUSTING INVERTEBRATE HABITAT TYPE F) *PATIRIELLA REGULARIS* – SAND HABITAT TYPE.
