*November 2020*  
**NAPIER  
FLOOD**

9 November 2021

**NAPIER**  
CITY COUNCIL  
*Te Kaunihera o Ahuriri*

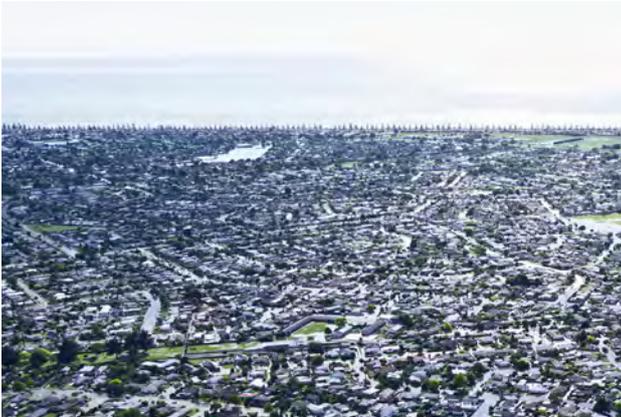
### **MARAENUI**

was severely impacted by flooding. Water remained for several days and some areas could not be accessed for up to 36 hours after the initial downpour. Flood water reached 75cm above ground level in parts. The majority of impacted homes were in Maraenui.

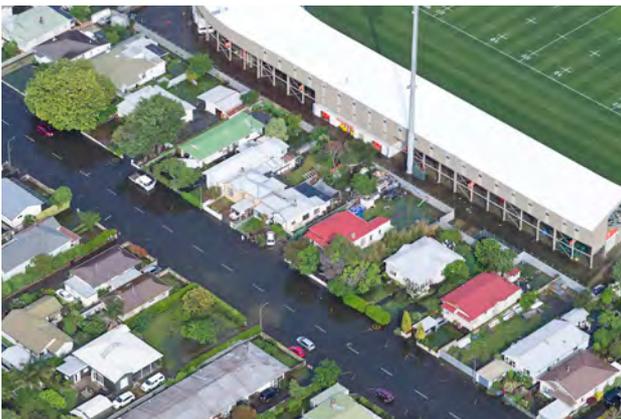
### **NAPIER SOUTH**

also experienced flood water up to 75cm above ground level. The most affected areas were near Latham Street and Georges Drive.

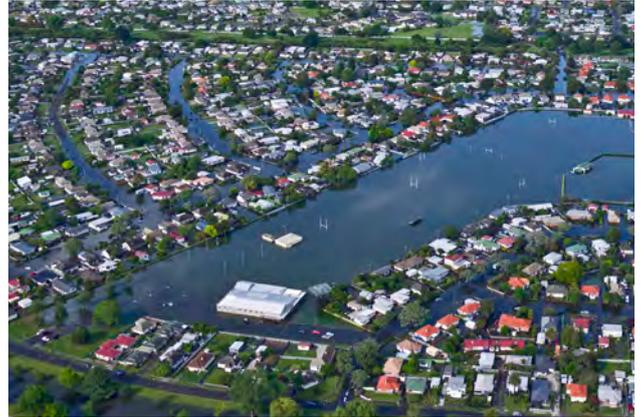
### **MAREWA**

also had flooding, particularly around the main drainage channel and pump station on Kennedy Road.

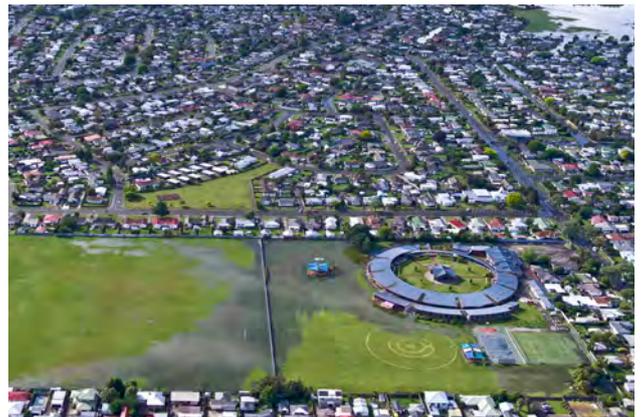
### **ONEKAWA**

flooding reached 80cm above ground level at times. It was centred around Ford Road, Wakefield Street and Niven Street with some commercial properties being flooded.

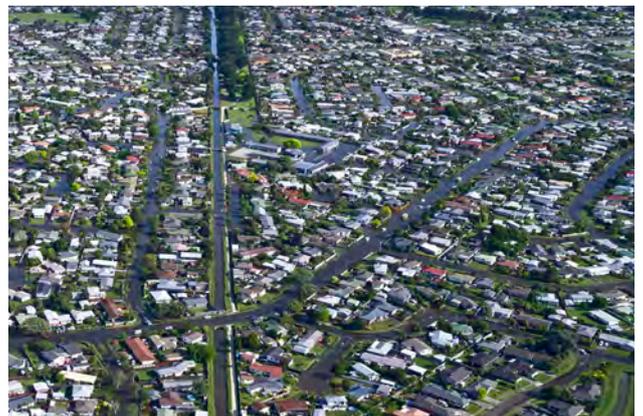
### **PIRIMAI**

experienced flooding particularly around Harold Holt Avenue and Bill Hercock Street where flood waters reached up to 90cm above ground level.

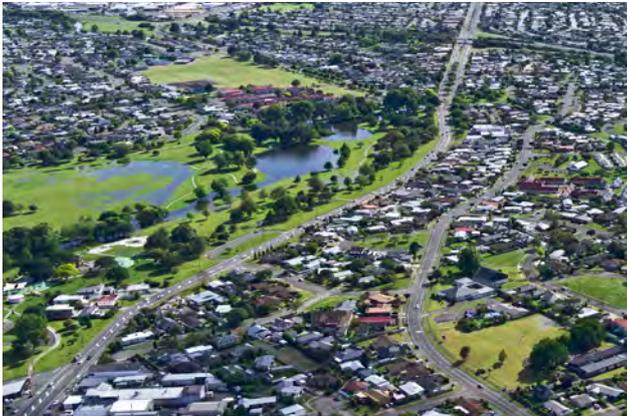
## TARADALE AND GREENMEADOWS

experienced flooding when the Taipo Stream overflowed. Stormwater ponded in an overflow area adjacent Kent Terrace and around Churchill Drive. Flood levels reached 50cm above ground level in Taradale and 40cm above ground level in Greenmeadows.

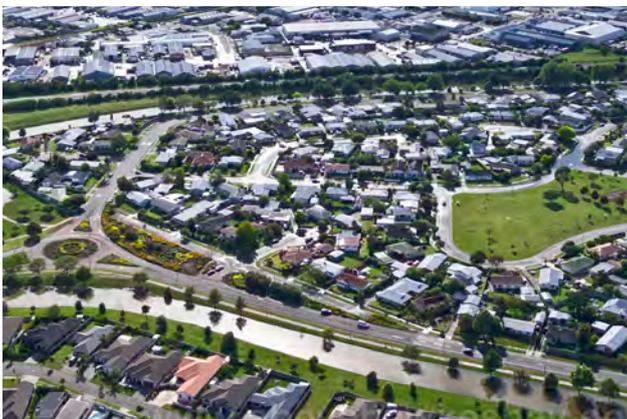
## TAMATEA

experienced flooding up to 20cm above ground level in some areas, particularly around Westminster Avenue and Saltwater Creek.

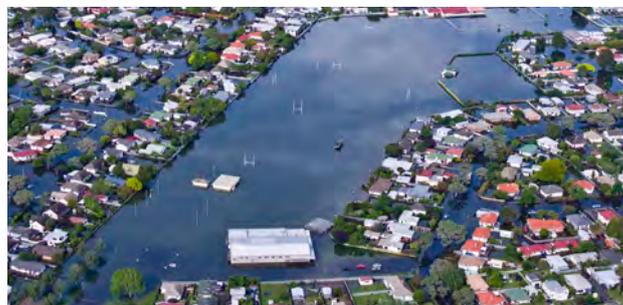
- Parks and open spaces stored significant volumes of water, preventing further flood damage downstream. In some cases, they were full to capacity and overtopped on spillways to roadways, as they were designed to do.

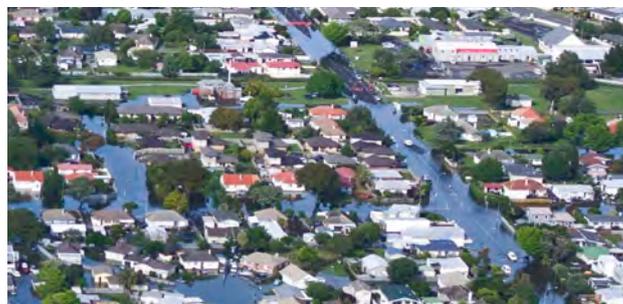
- Roadways stored water and successfully prevented some flood damage. There were cases where the flood damage was not prevented because residents in large vehicles drove through streets before the flood subsided and pushed waves of water onto private properties causing unnecessary damage.

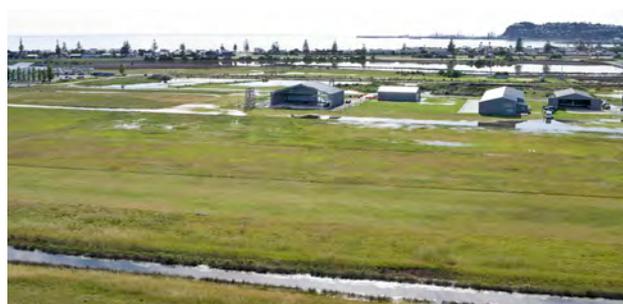
- Waterways stored and conveyed large amounts of water, although there were points where they were constrained by undersized culverts, causing more flooding upstream than would have occurred if the culverts had been upsized. These culvert upgrades had already been identified before the storm and are budgeted in the Long Term Plan.
